TOWN OF CARRBORO, NORTH CAROLINA  
SPACE NEEDS ASSESSMENT  
BOARD OF ALDERMEN PRESENTATION  
SEPTEMBER 27, 2016

## Town of Carrboro Facilities Assessment

# STRUCTURAL FACILITIES CONDITION ASSESSMENT

**MEP ENGINEERING EXISTING FACILITY ASSESSMENT**

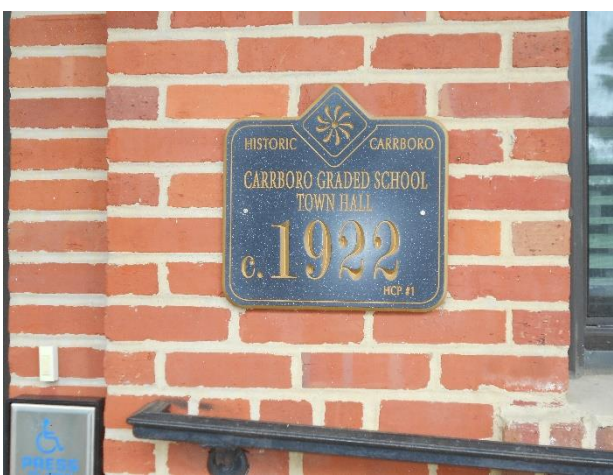
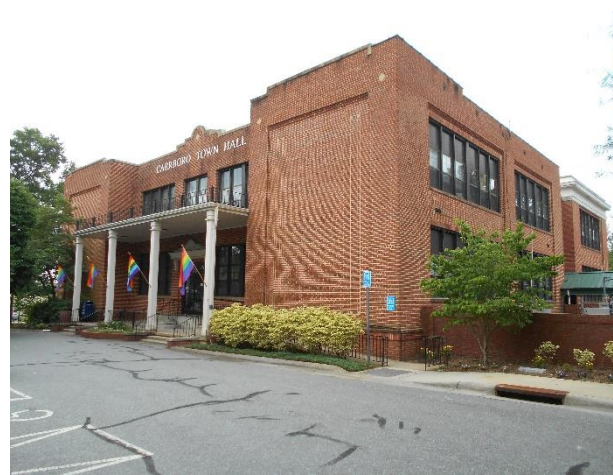
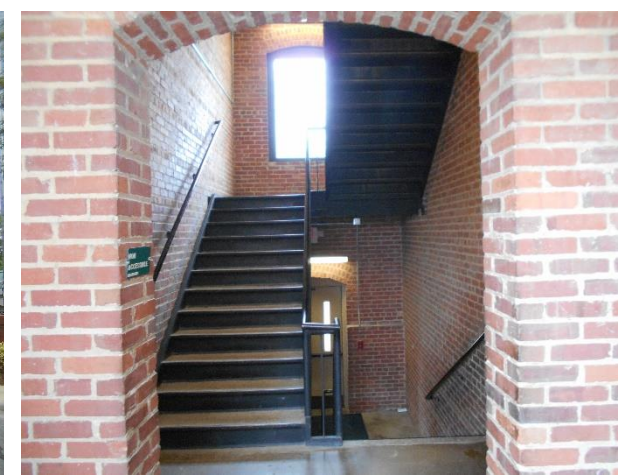
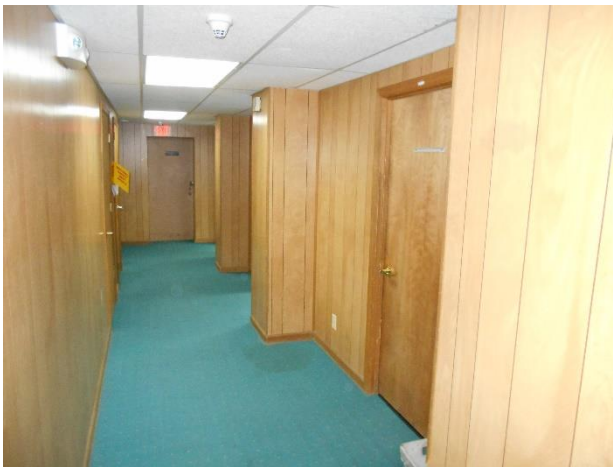
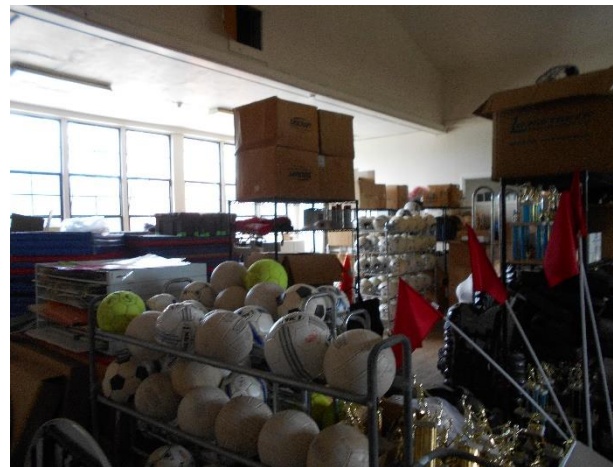
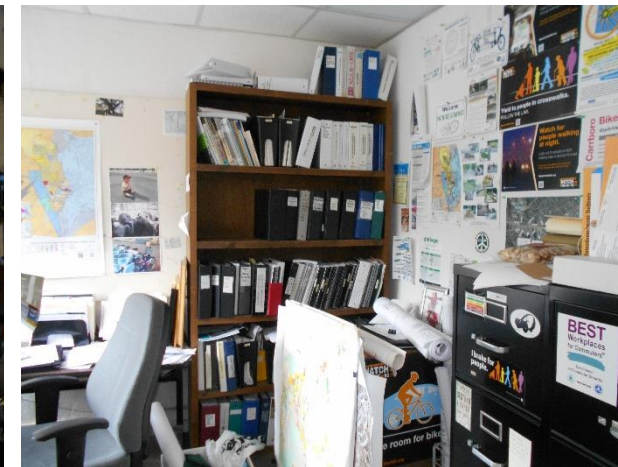
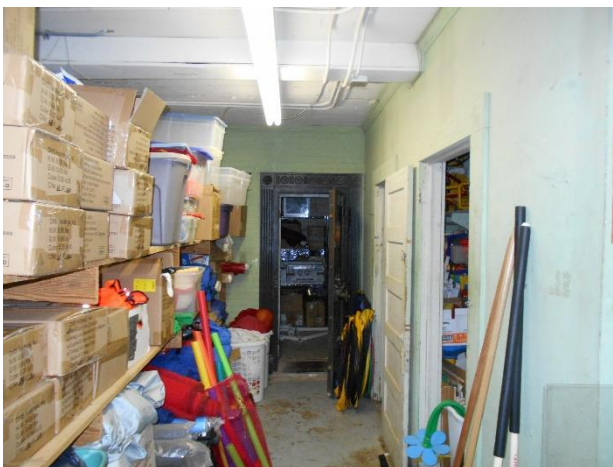
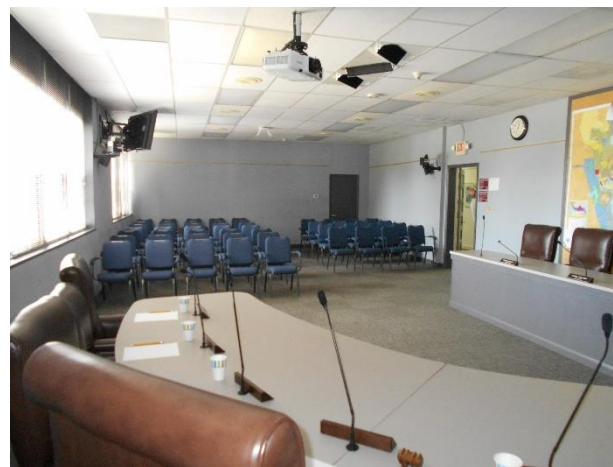
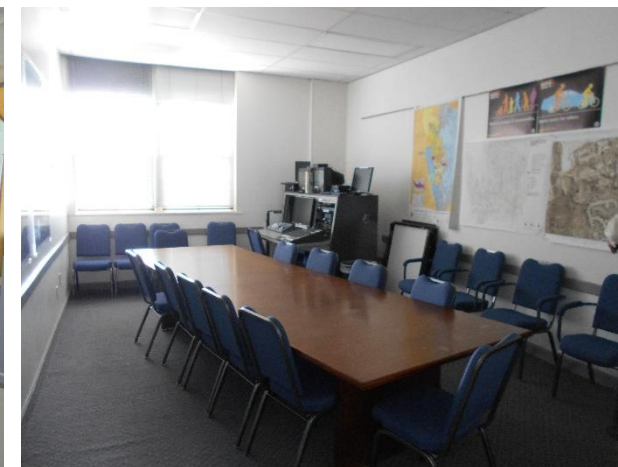
- Building has architectural character and is a landmark in the community
- Shortage of conference room space and AV equipment
- Board room often at capacity for regular meetings
- Lack of acoustical separation
- Restrooms in a difficult location
- Potential of upper floor and attic space
- History of flooding in areas of the basement
- Security risk of public access to most of the building

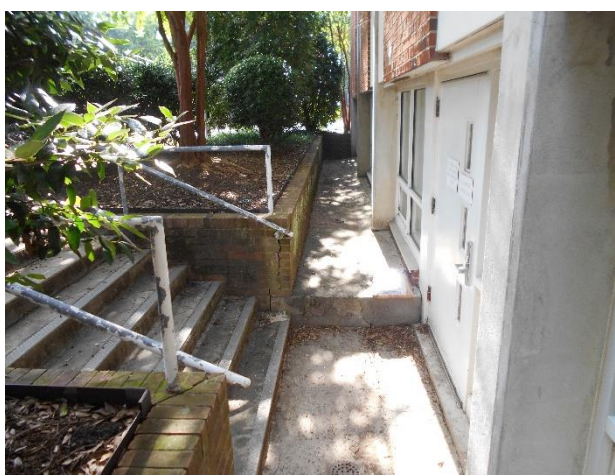
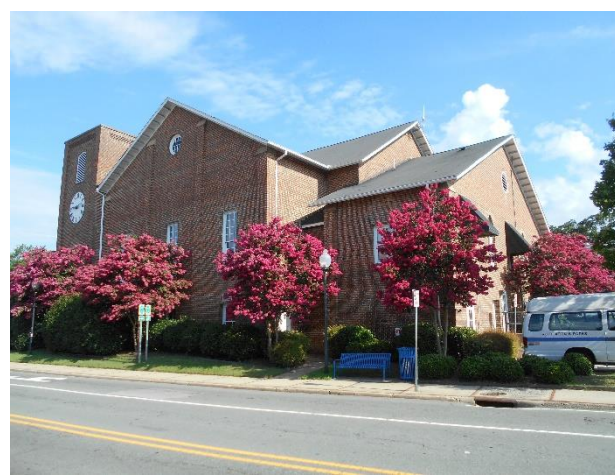
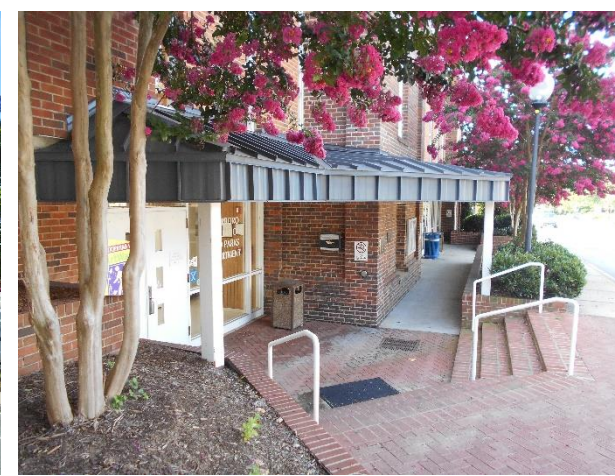
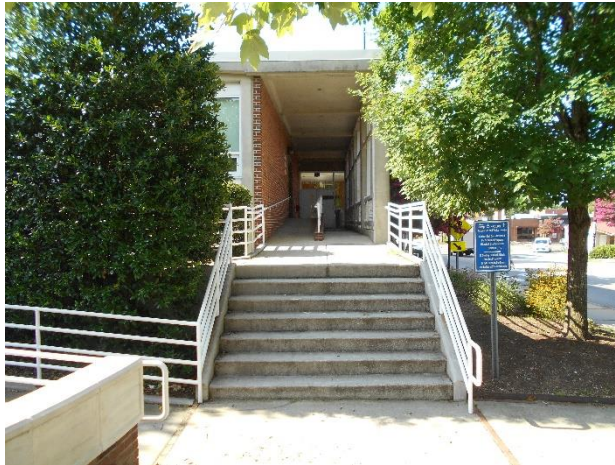
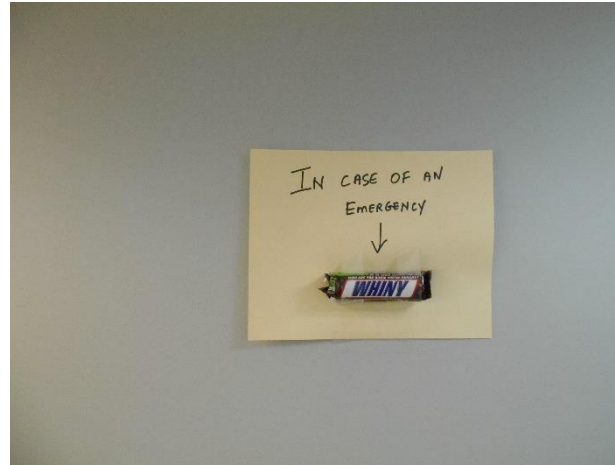
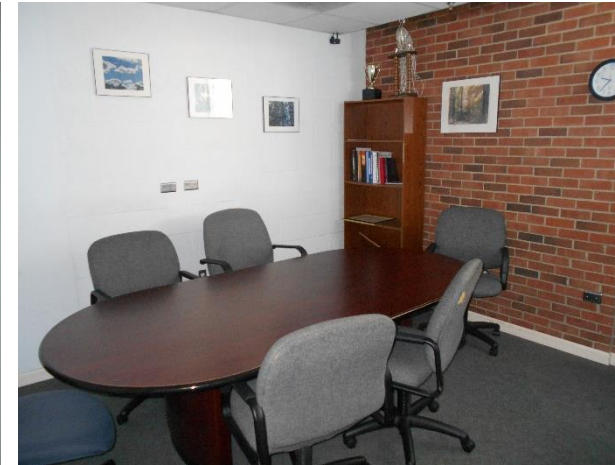
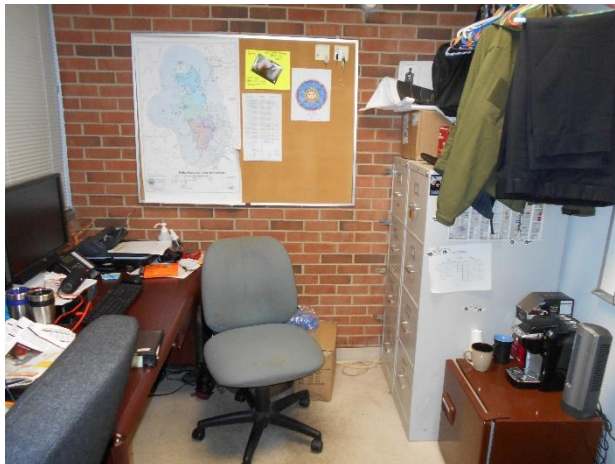
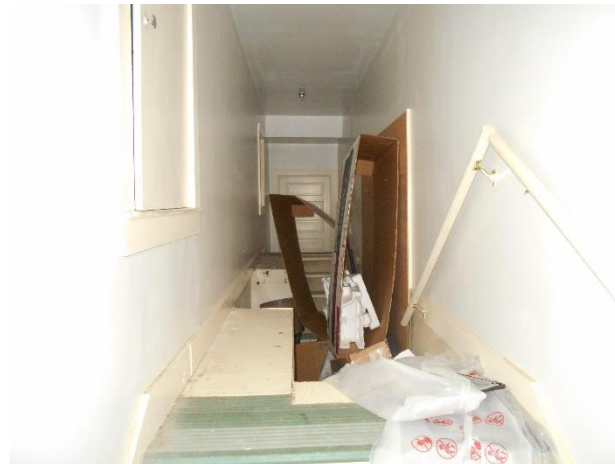
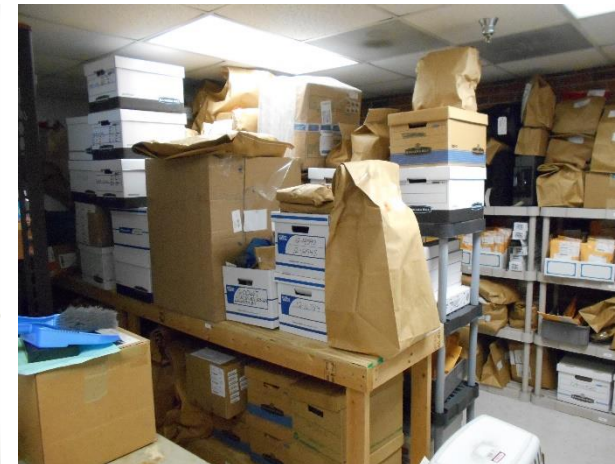
- Building has nice rental amenities including the Century Hall space
- Central downtown location
- Challenging relationship to street level requires multiple ramps and concealed entries
- Lack of identity for either police or recs and parks as a civic entity
- Several office spaces interior to the building with no access to daylight
- Lack of secure area for police detainee transfer in rear parking lot

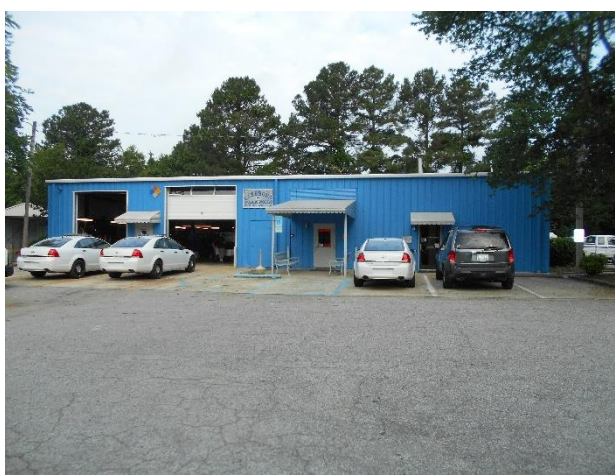
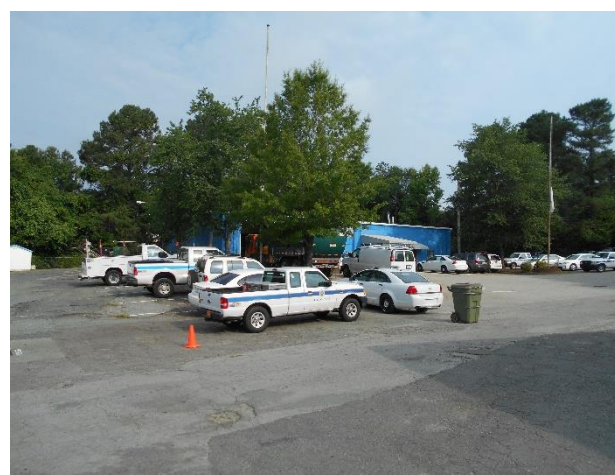
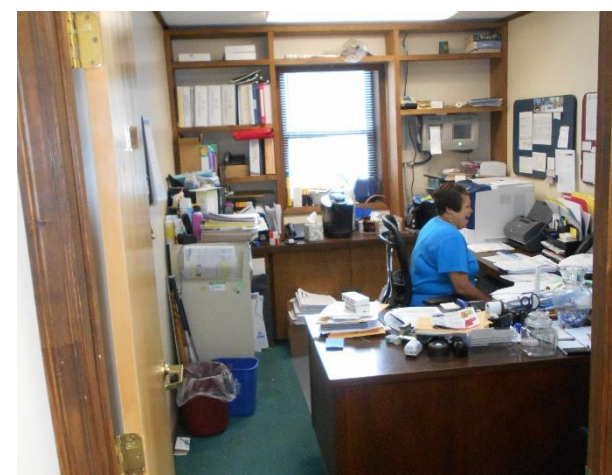
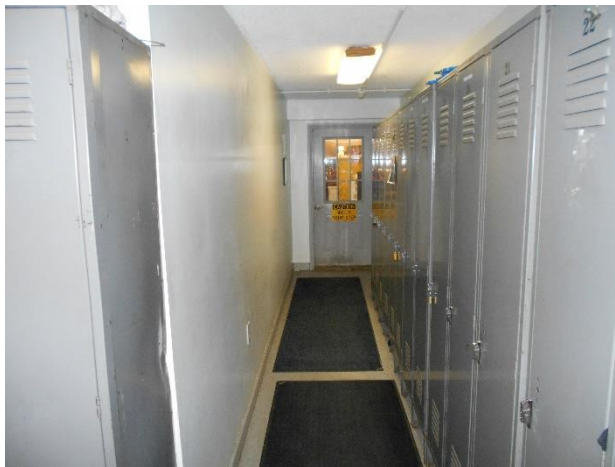
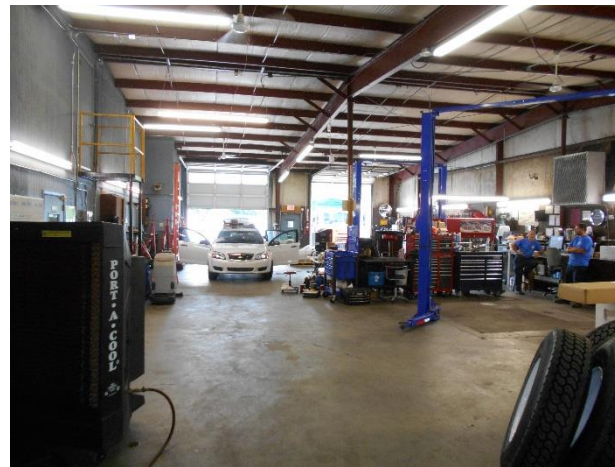
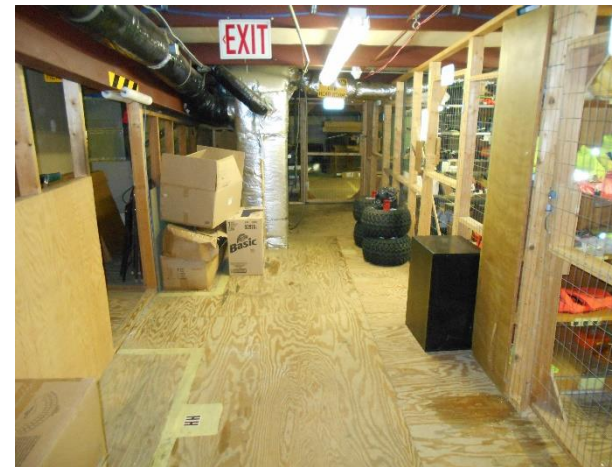
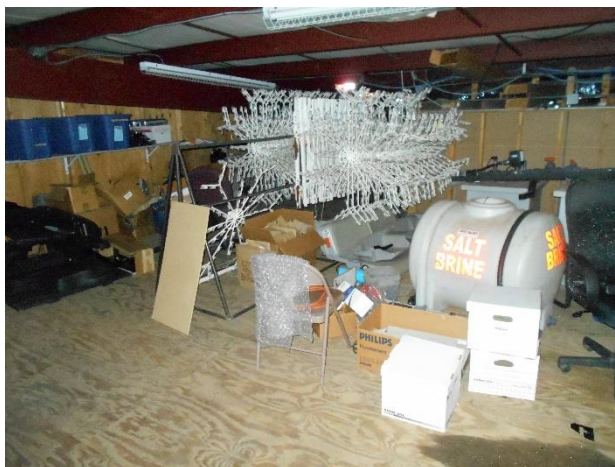
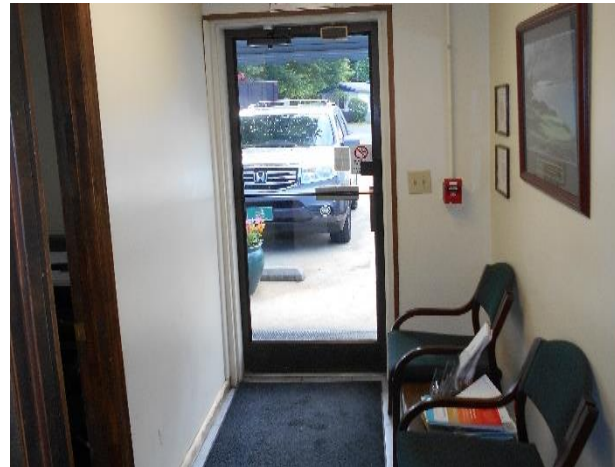
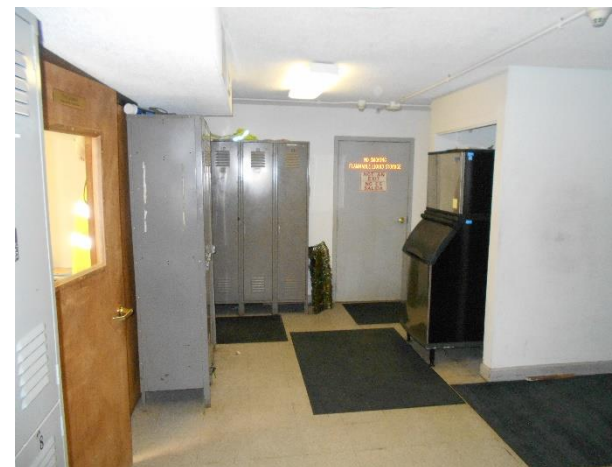
- Site is centrally located near downtown and most town facilities
- Most office deficient in space and storage
- Conference/training/break room shared space has too many functions and limits access
- Shortage of female restrooms
- Property subject to flooding in proximity to fleet vehicle parking areas
- Vehicle bay too short for maintenance on some fleet vehicles
- Police conversions and vehicle evidence processing occupies valuable bay space
- Public access to the site for mulch program

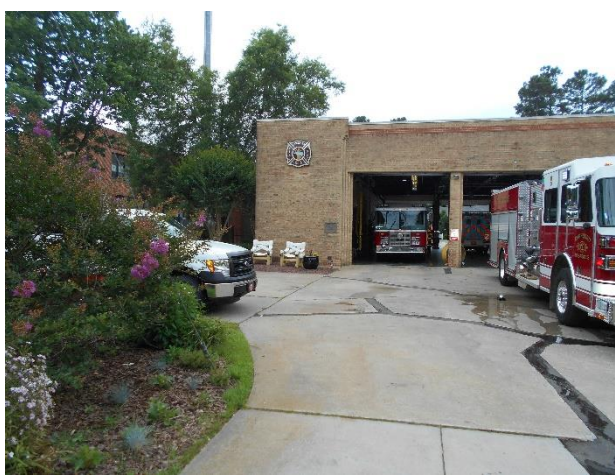
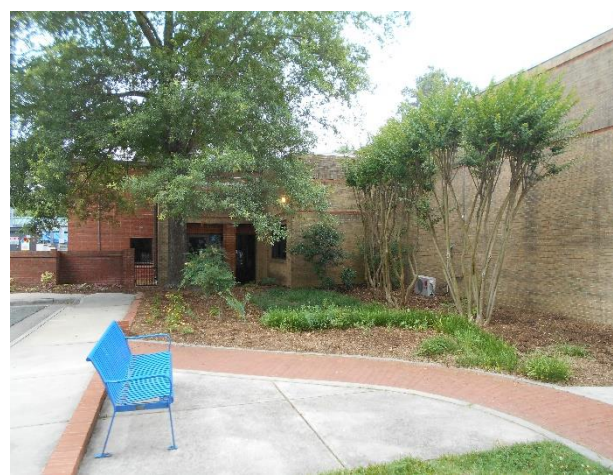
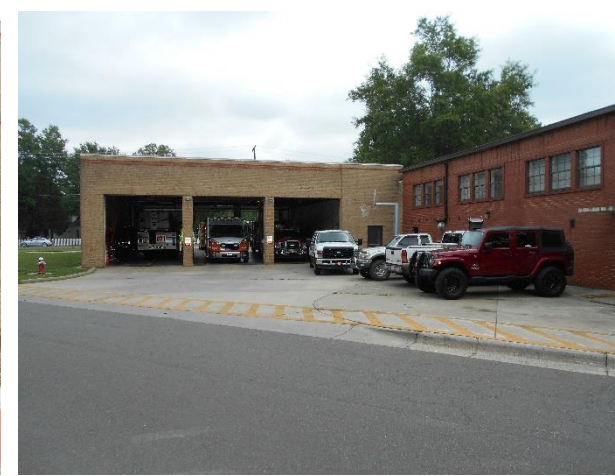
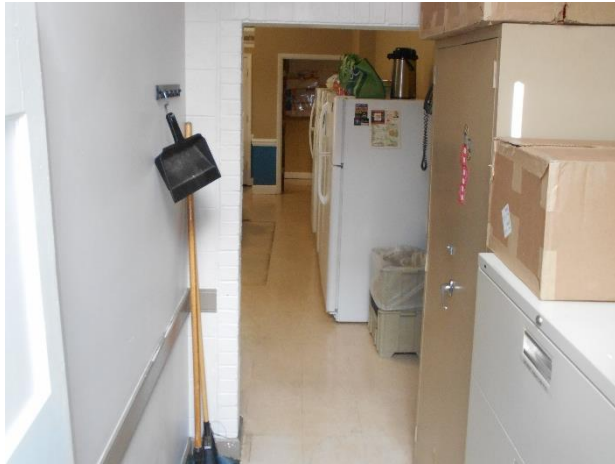
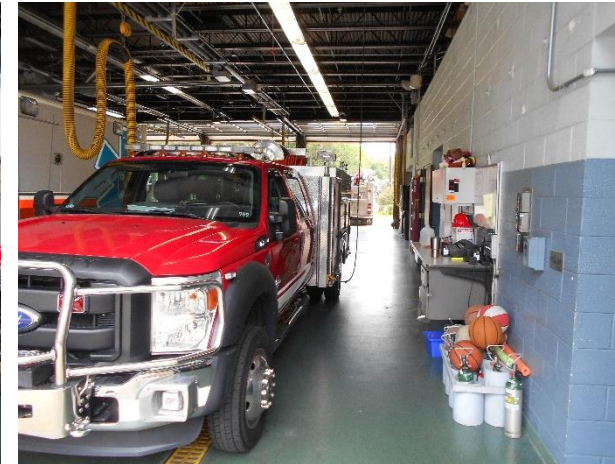
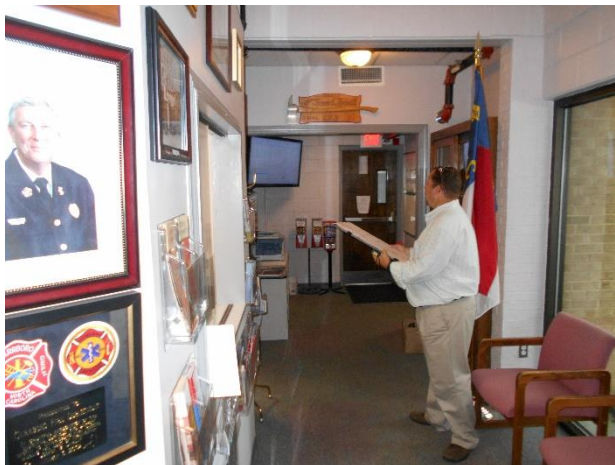
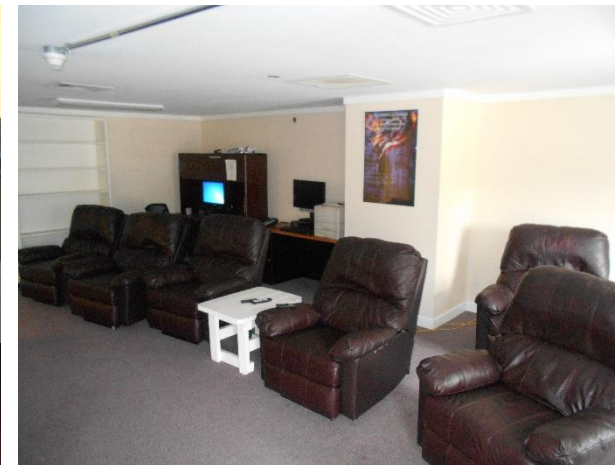
- Site is centrally located near downtown
- Shortage of parking spaces
- Apparatus bays are lacking in space and height – some vehicles being parked outside
- Lack of separation between administration and station functions
- Conference room under utilized due to lack of AV
- Sleeping quarters very cramped
- No secure public lobby
- Training room shared with other departments

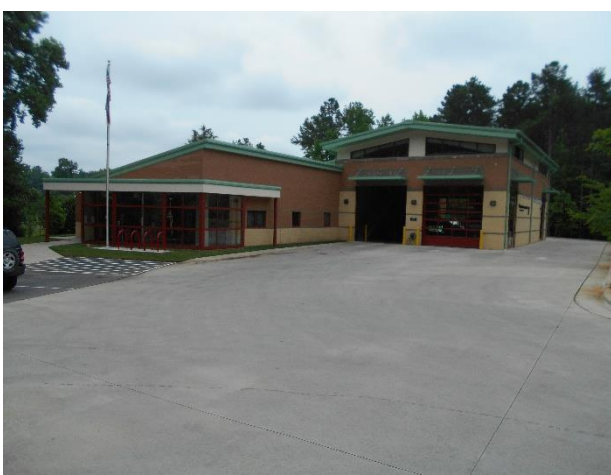
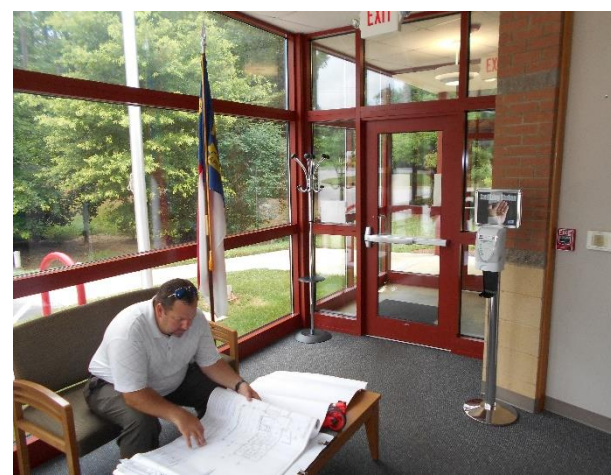
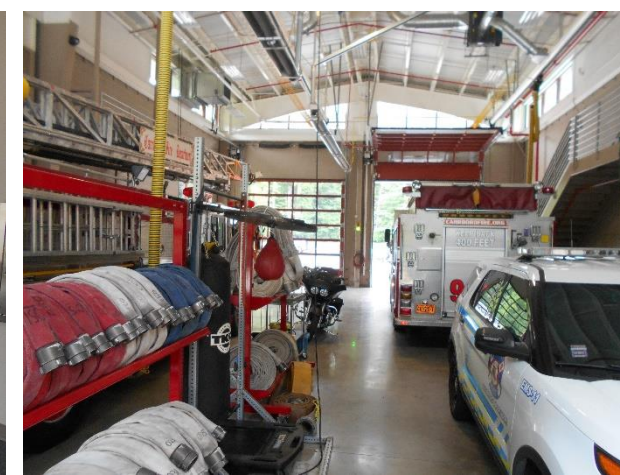
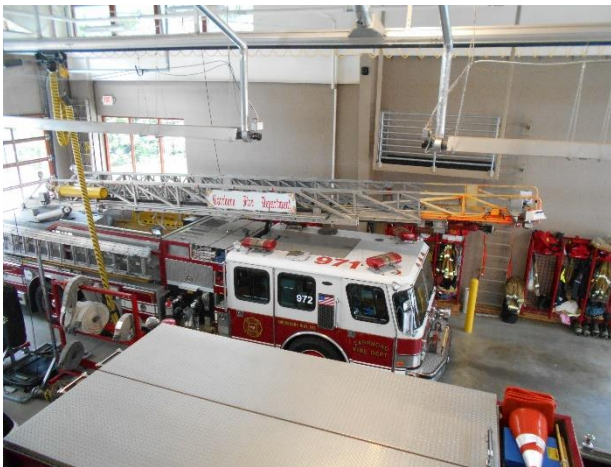
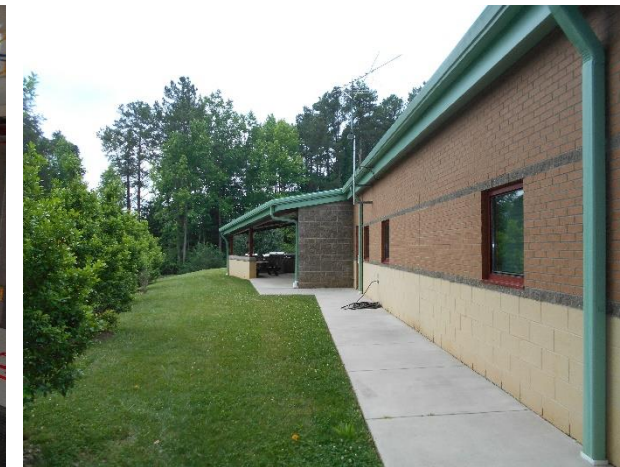
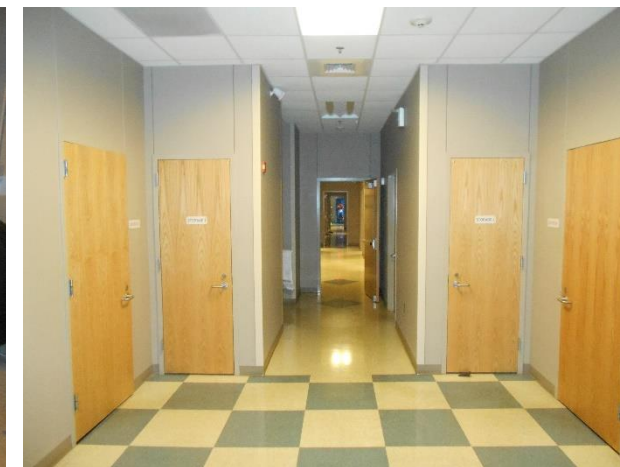
- Newest facility owned by the Town and in great condition
- Sited for potential expansion of apparatus bays
- Shared sleeping rooms
- Nice kitchen
- Height of apparatus bays adequate but the length for double stacking is lacking
- Police substation
- Nice outdoor patio space
- Adequate staff parking
