Town of Carrboro

Facilities Condition Assessment

October 2019

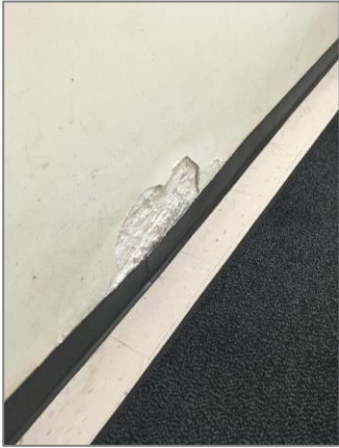
Wall Repair

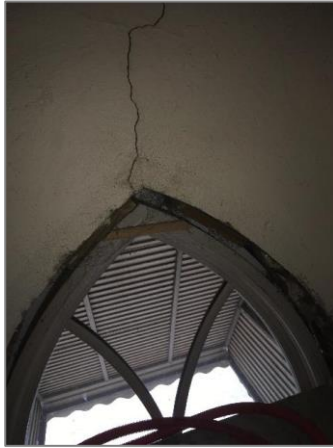
Attic - Exterior Wall

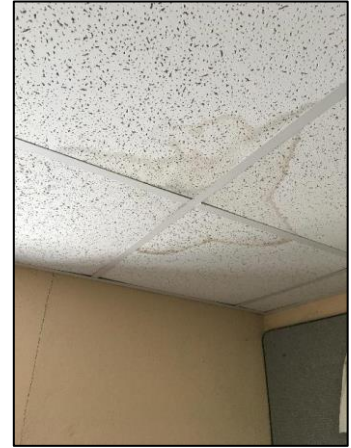
Damaged Ceiling Tiles

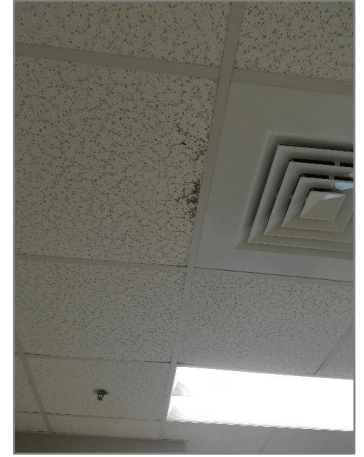
Ceiling Tiles

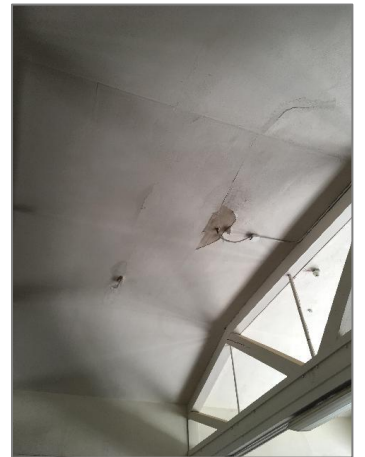
Auditorium - Ceiling

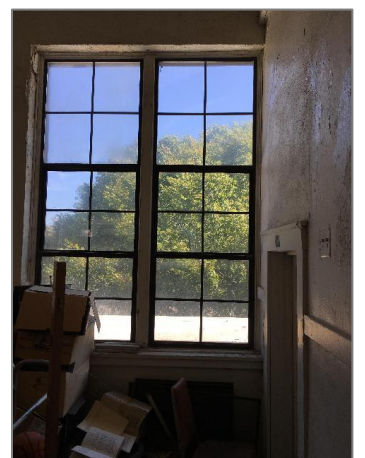
Window

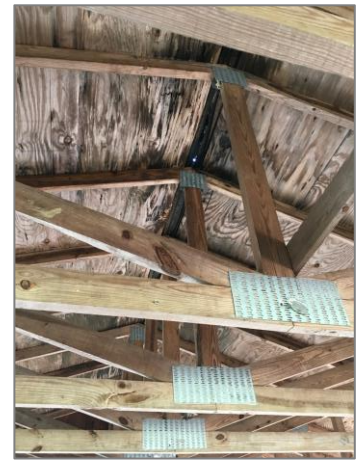
Picnic Shelter Roof
