DRAFT PRELIMINARY ENGINEERING REPORT

Piedmont Health Center Hydrologic Report

**THE TOWN OF CARRBORO
CARRBORO, NORTH CAROLINA
May 6, 2016**

PIEDMONT HEALTH CENTER PRELIMINARY HYDROLOGIC REPORT

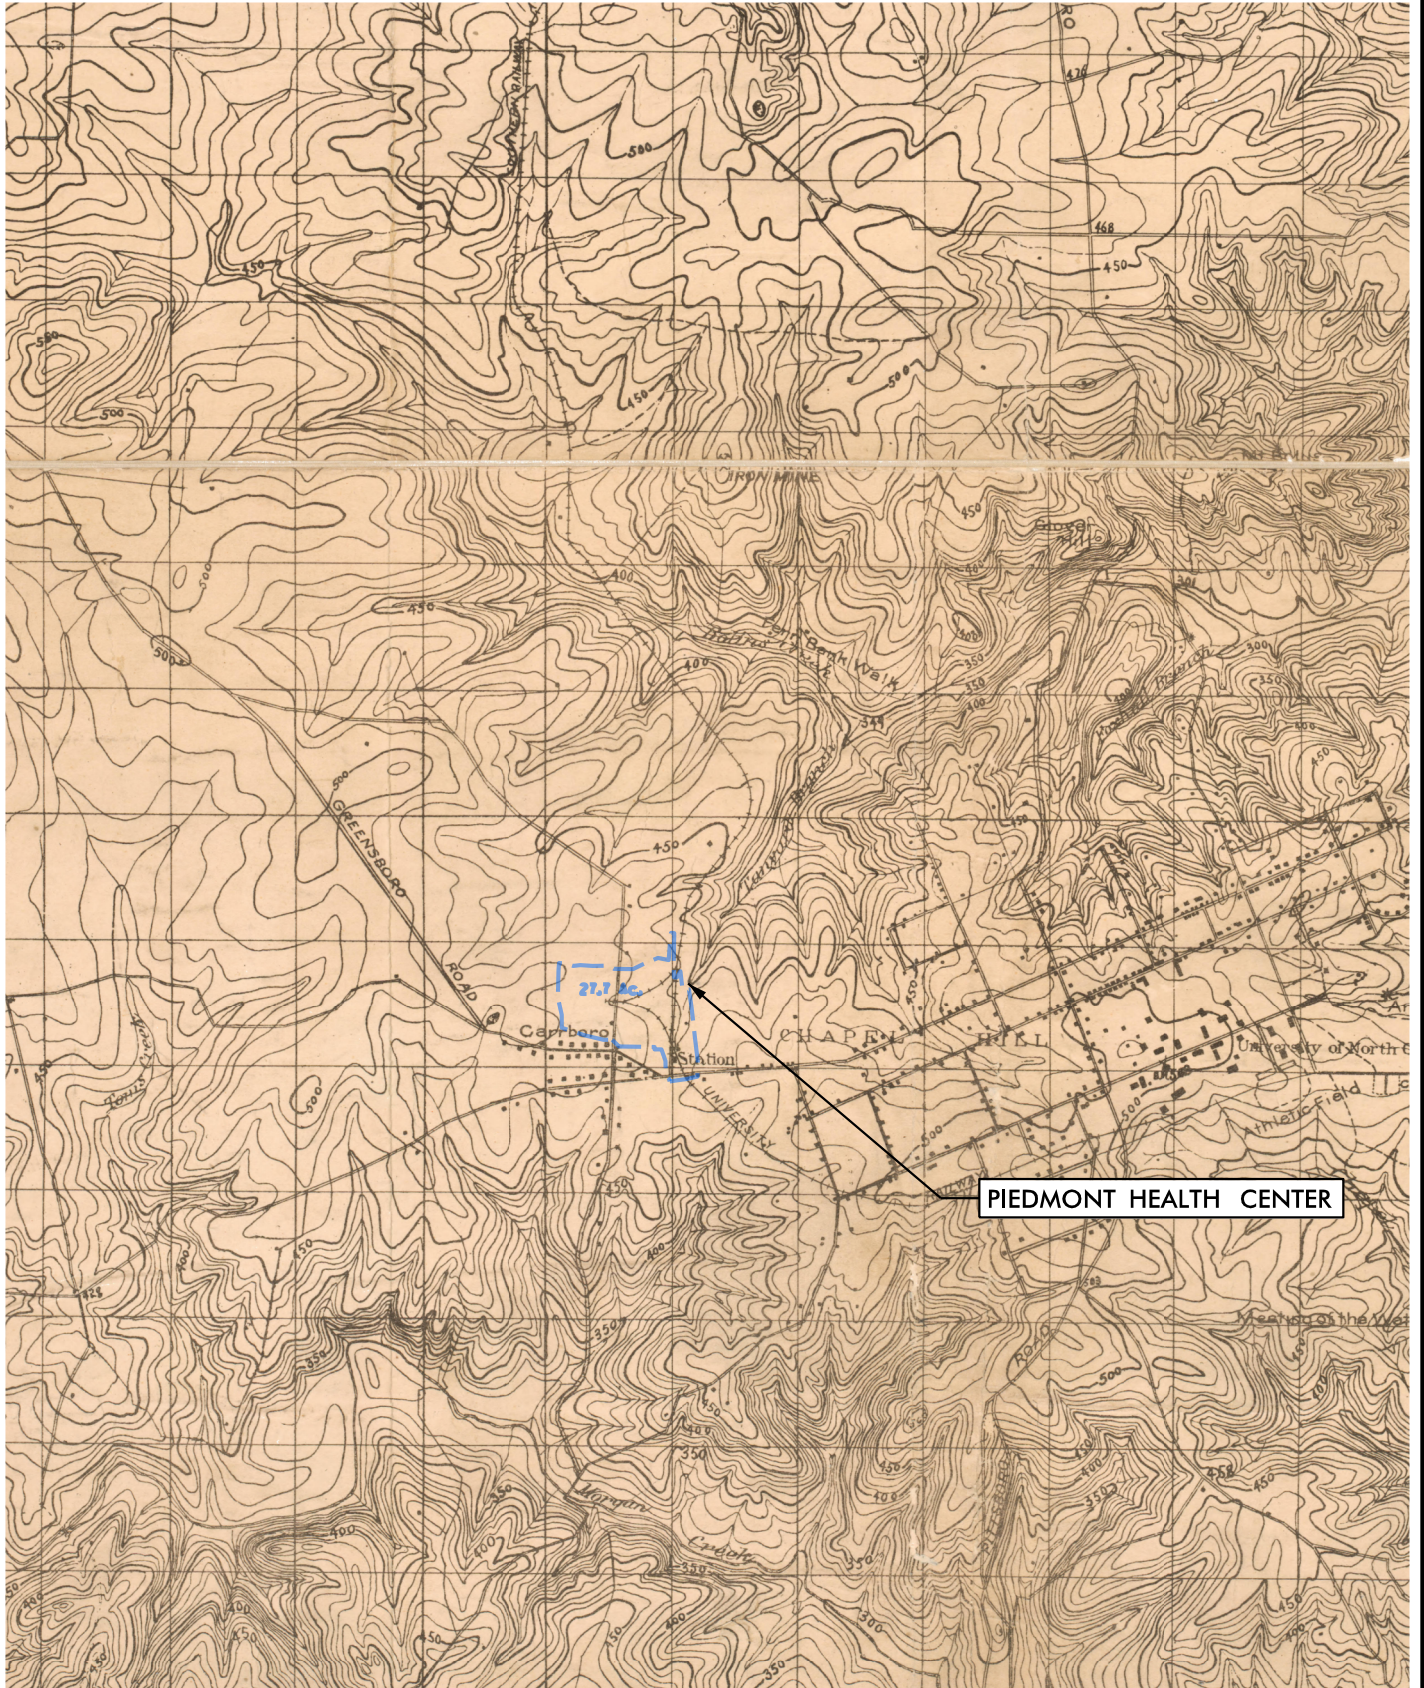
APPENDIX A
PIEDMONT HEALTH CENTER
1918 USGS QUAD MAP
ORANGE COUNTY
SCALE: 1" = 2000'

The watershed above the Center is the headwater to Tanbark Branch. Tanbark Branch technically begins just downstream of the Piedmont Health Center site according to the Town of Carrboro GIS and USGS topographical mapping. Upstream of the site, the stream has been replaced by manmade ditches, roadway and railway ditches and long pipe systems as a result of urbanization in the watershed. No semblances of a natural channel currently exist within the upstream watershed. The Norfolk Southern /UNC railroad is immediately upstream of the Center site. All of the discharge entering the drainage system at the Center comes directly through cross pipes and rail side drainage ditches. Based on historical topographic mapping of Carrboro dated 1918 (**Appendix A**), it appears that the rail and associated spur lines were in existence at that time and predate any construction on the Health Center site.

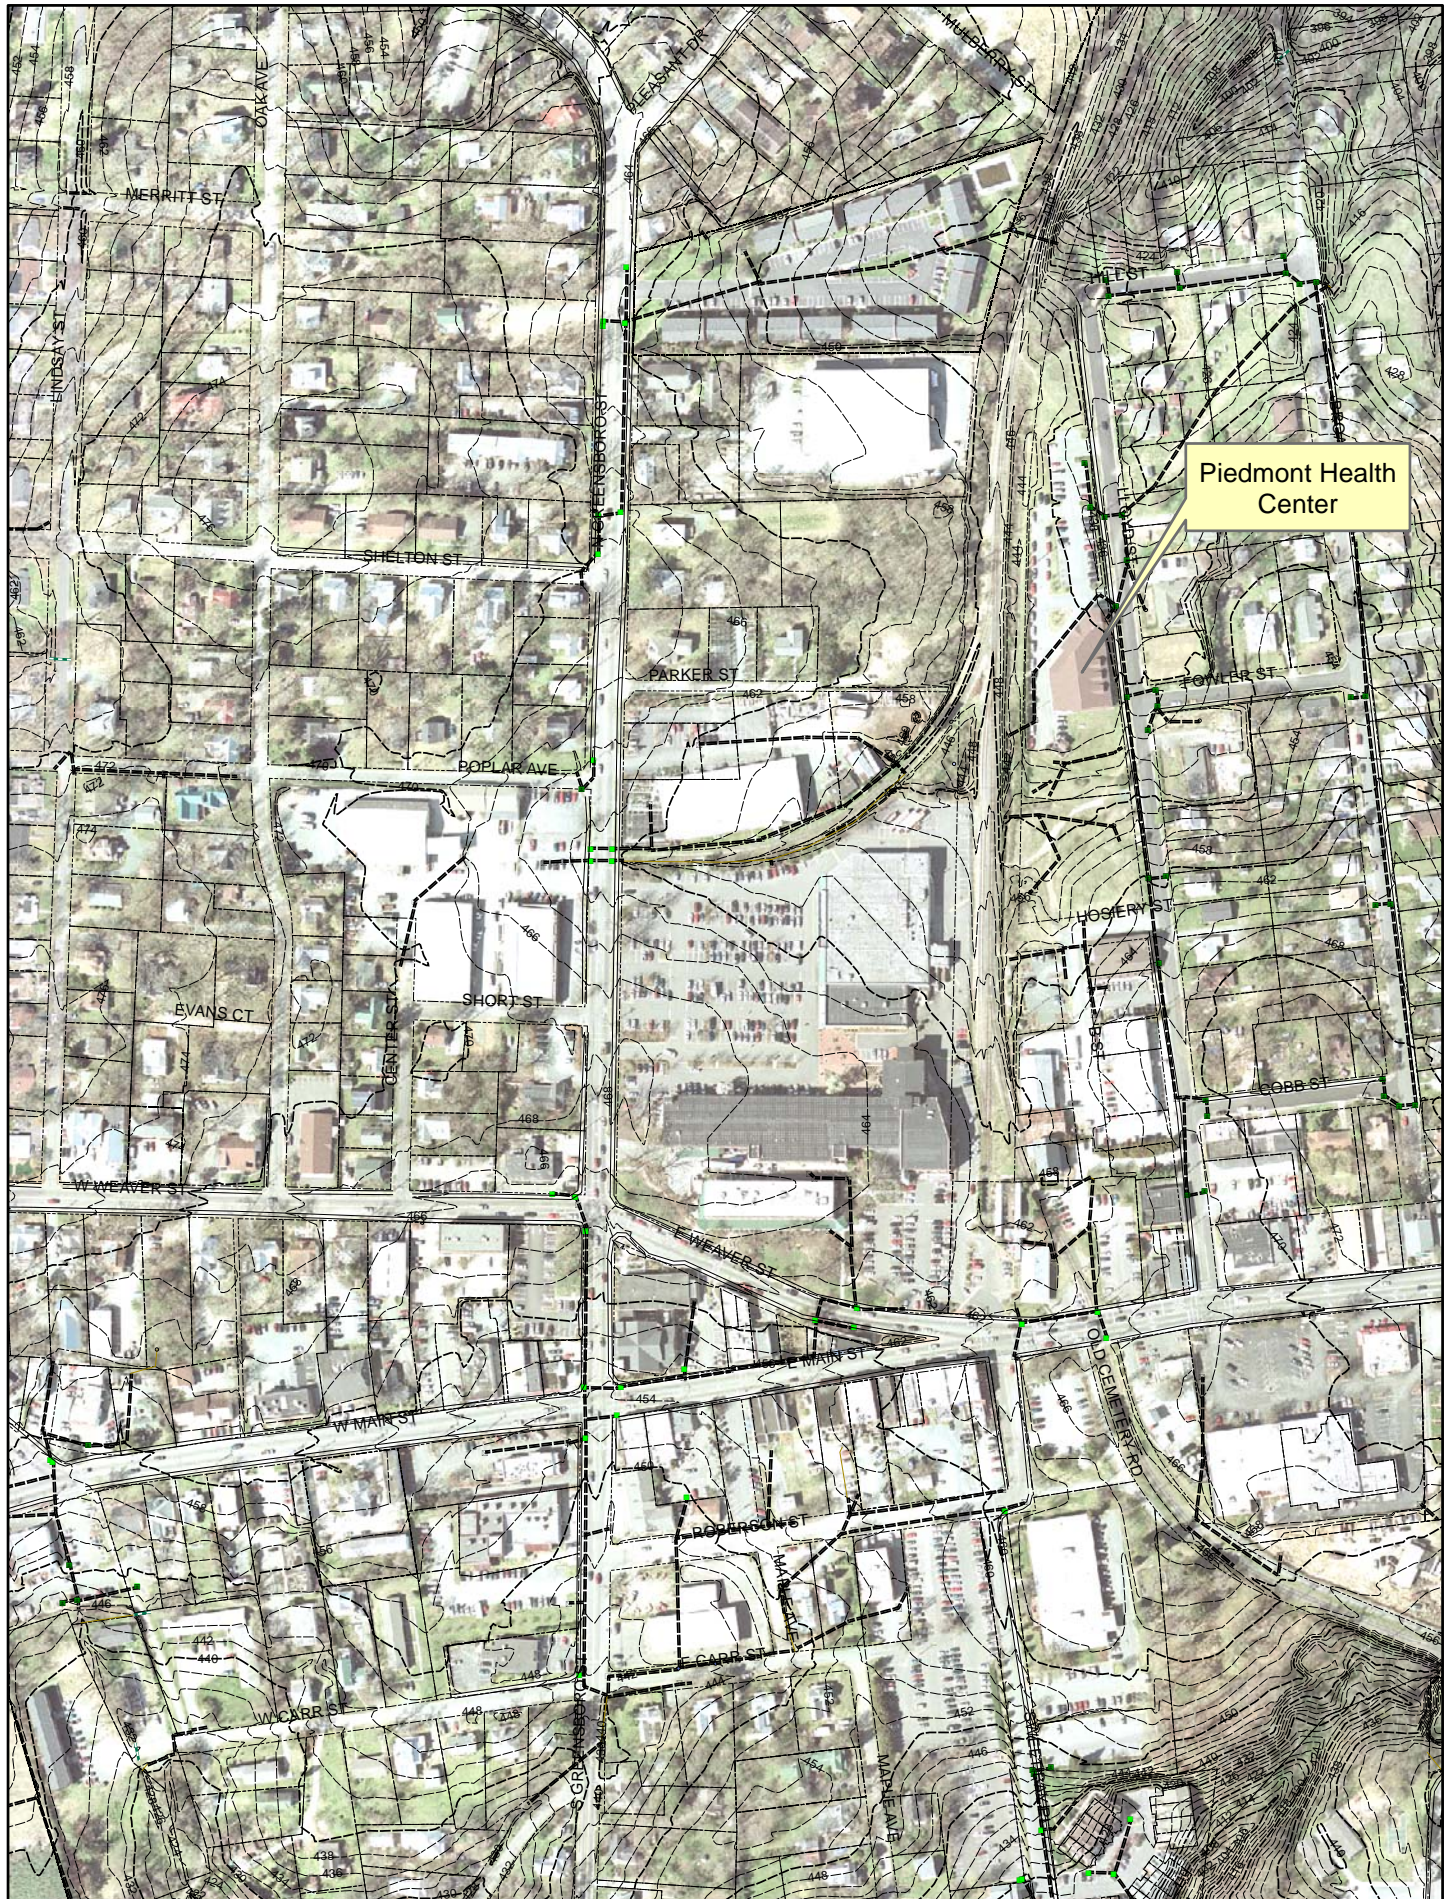
Piedmont Health Center Area Map

Sungate obtained available TOC GIS, zoning and contour data to create a preliminary base map (**Appendix B**). Current and historical USGS topographic mapping was also

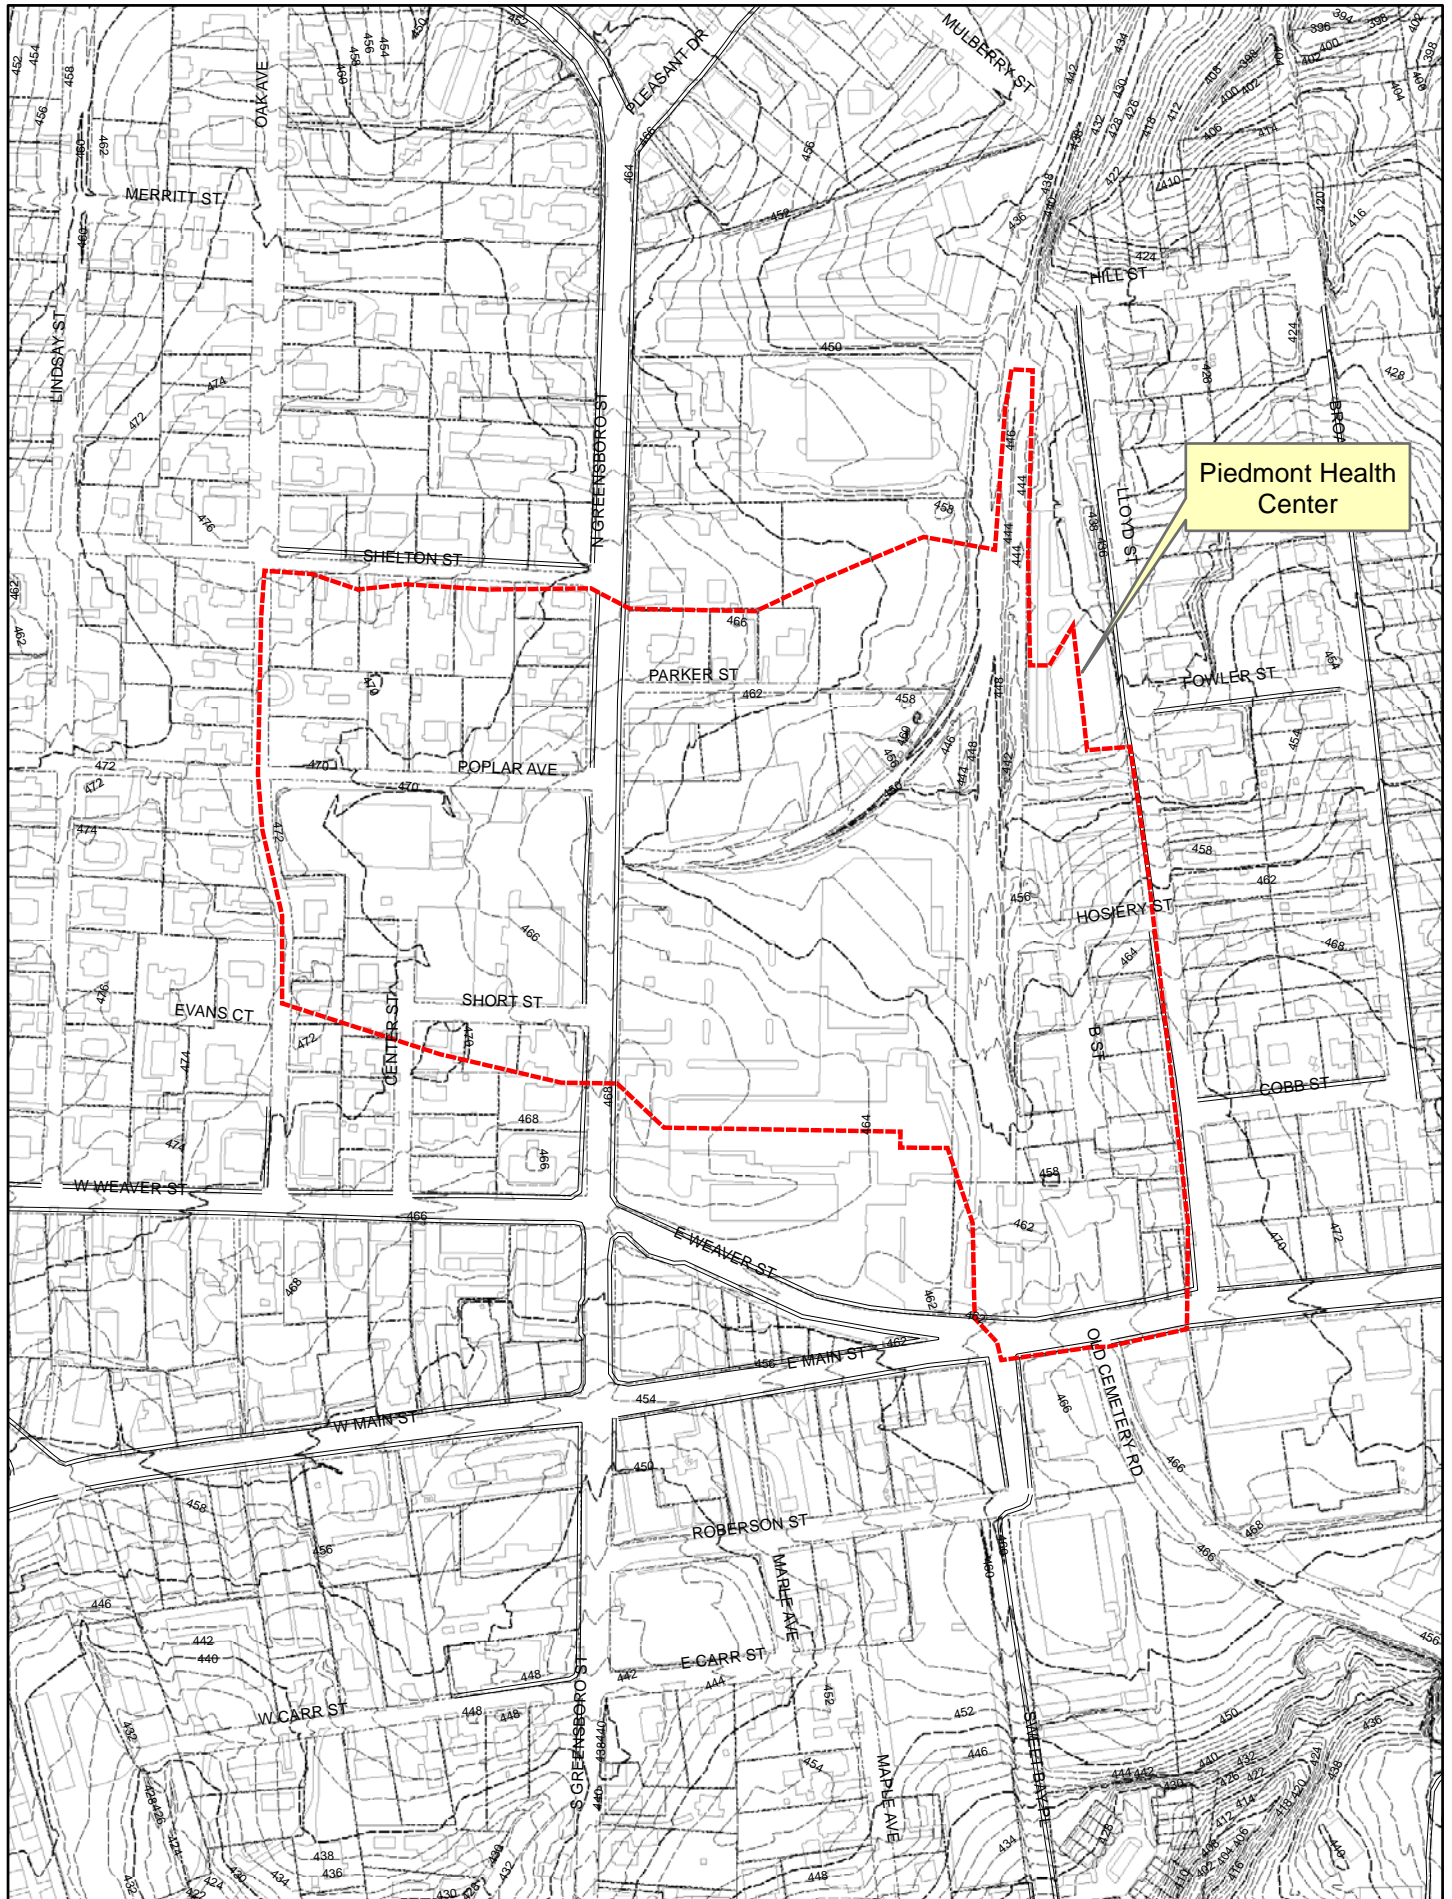
Piedmont Health Center Drainage Area Map

The drainage area at study location was delineated using the available contour data and field verified. The total drainage area to the 24" inlet pipe to the system at the Health Center is 27.7 acres (**See Appendix D**). According to the latest TOC Zoning maps, the land within the contributing drainage area is zoned for Business (84 %), and Residential

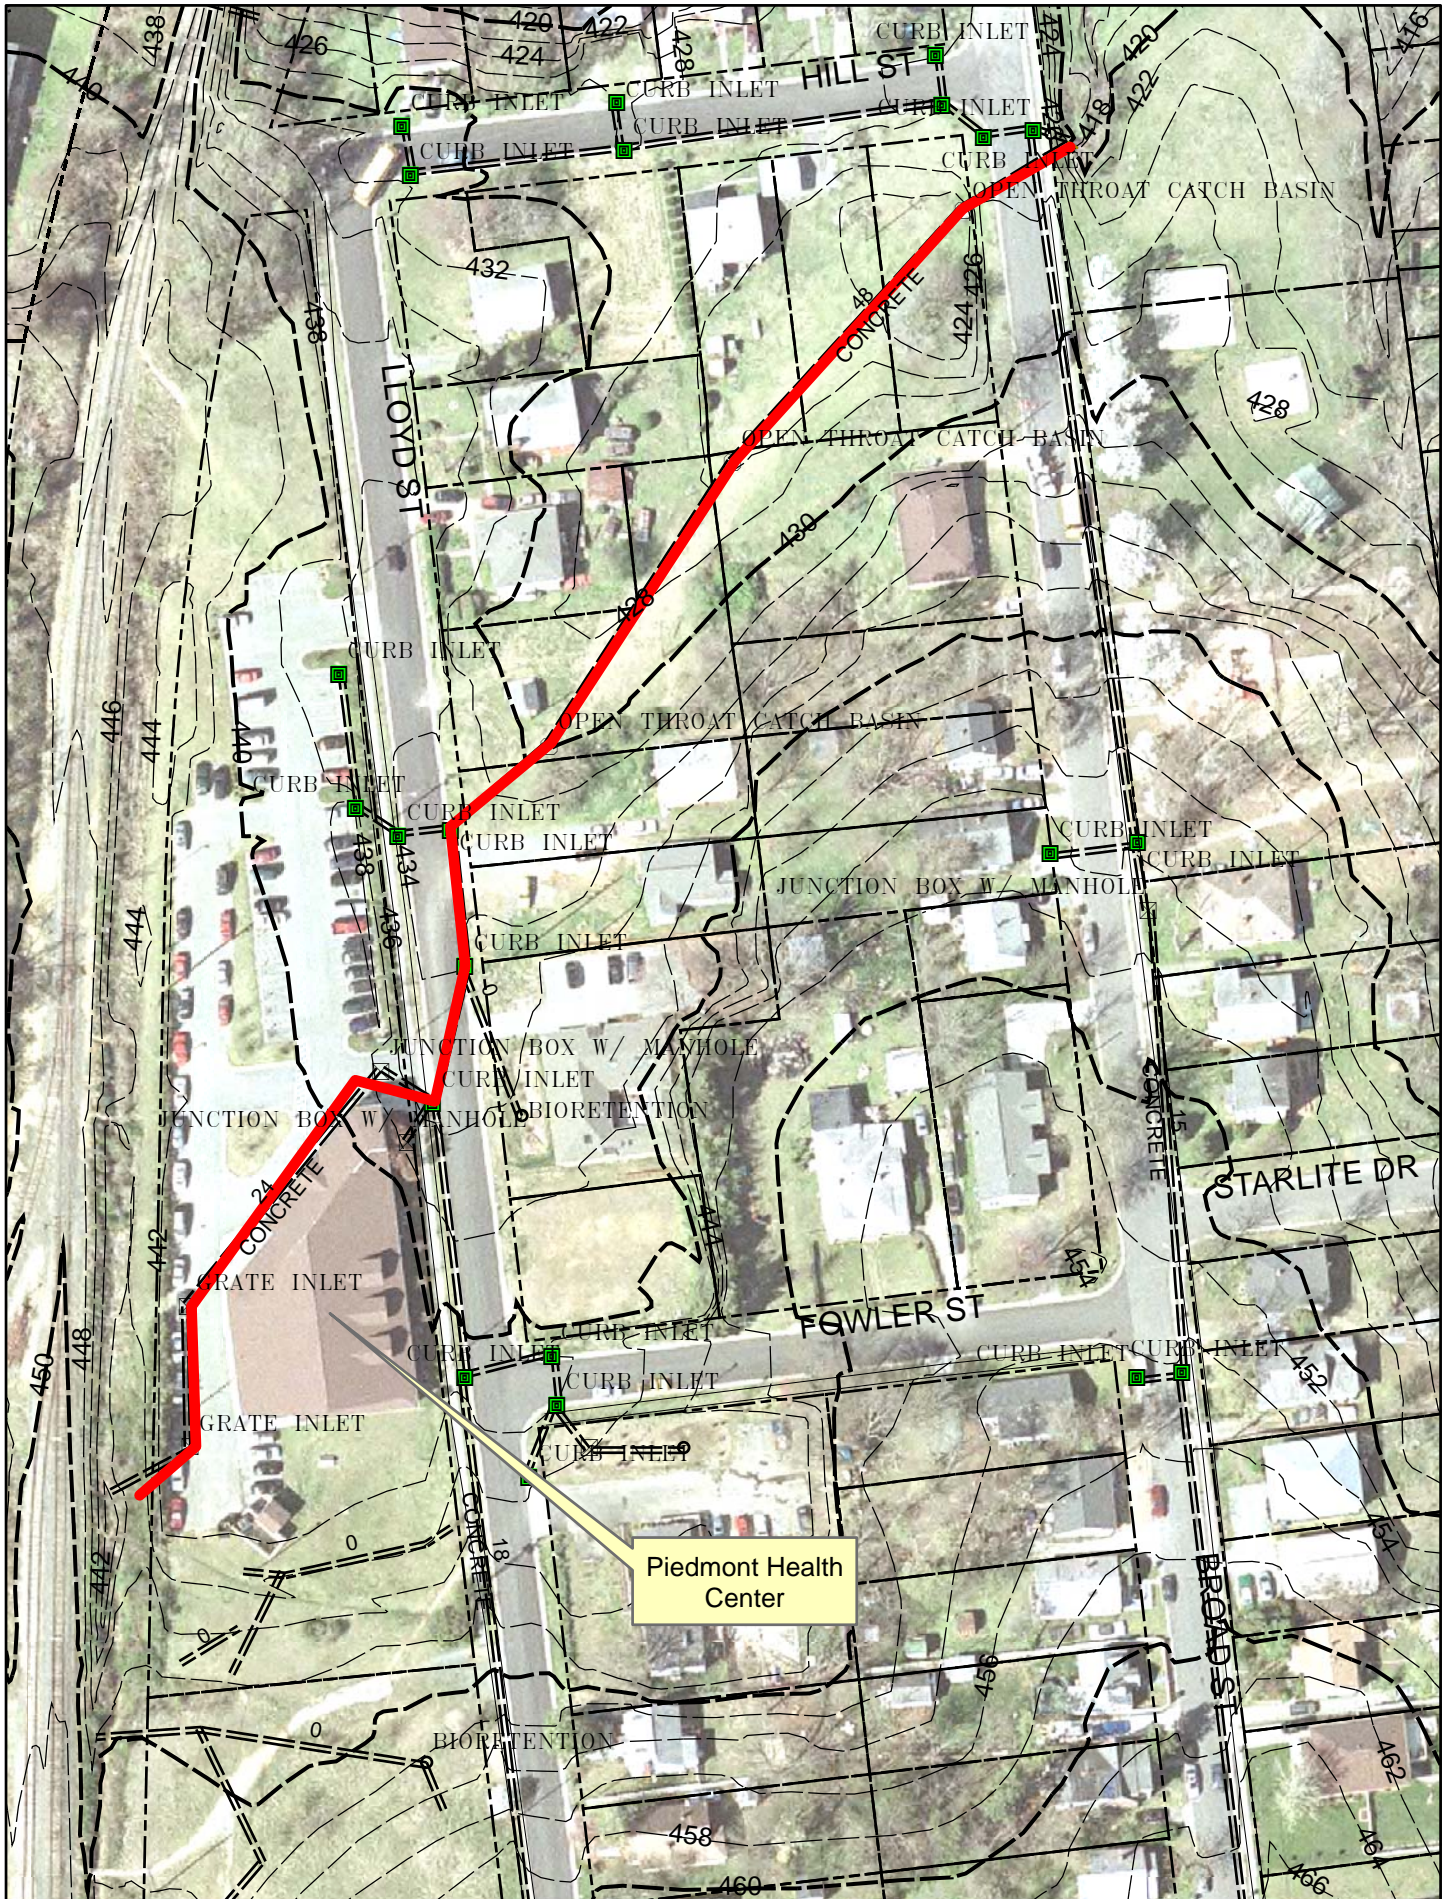
Piedmont Health Center Alternative #1 - 2@48" RCP

According to the Carrboro LUO, this crossing should be sized to handle the 25-year storm event. In order to meet this requirement and not overtop the railroad ditch berm, a 66” RCP open-end pipe would be required. Due to the topographical constraints, the largest pipe that could presently be installed and still have a minimum of 1’ of cover would be a 60” pipe. If a 60” pipe were to be used, storm events greater than the 10-year event would continue to overtop the existing berm and spill into the parking lot.

Therefore, 2 @ 48" pipes would be required in order to allow sufficient cover due to limited elevation difference between the railroad ditch bed elevation at the inlet to the existing 24" pipe and the berm elevation. Installation of a pipe system this large would require significant excavation in the Health Center parking lot and would require enlargement of the receiving downstream system in Lloyd Street, through private property and under Broad Street (**See Appendix E**). It does not appear that the increased discharge at the outlet of the system would cause any flooding of existing structures; however, erosion of the outlet channel may increase due to the increased discharge.
