DRAFT ENGINEERING REPORT

Recurrent Flooding Issues

**THE TOWN OF CARRBORO
PUBLIC WORKS DEPARTMENT**

Recurrent Flooding Problems in Carrboro

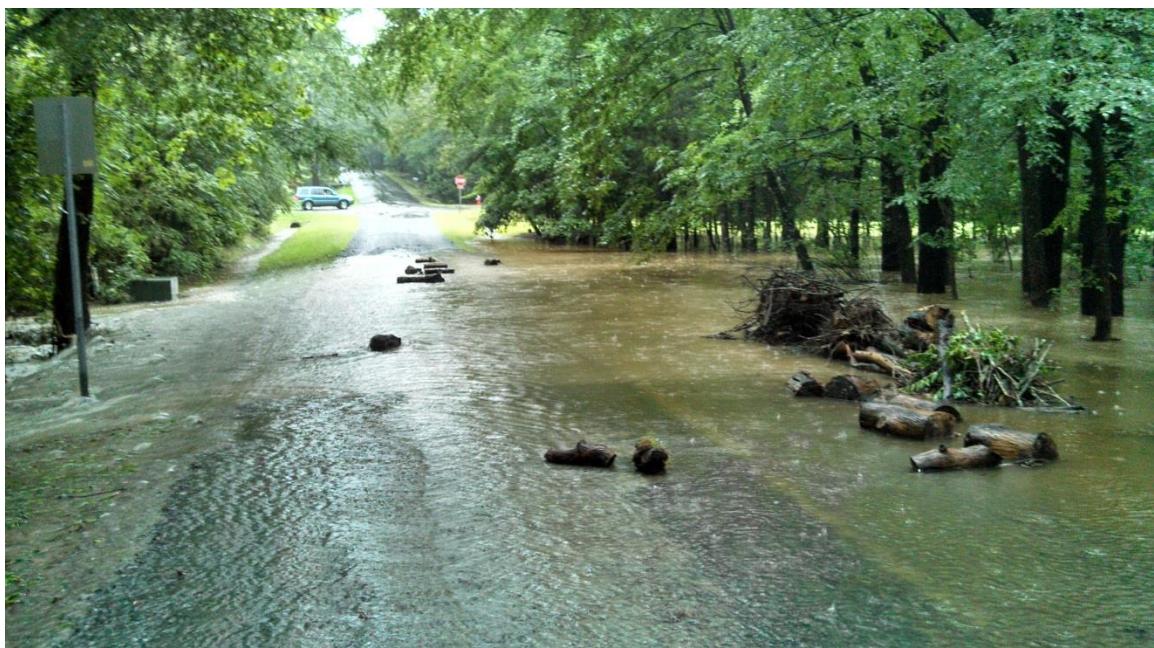
Rainbow Drive on June 30, 2013

4. Rainbow Drive – There are 2@ 30" pipes currently under Rainbow Drive on Tom's Creek. The culverts currently cause backwater in the 100-year storm event which causes Rainbow Drive to overtop. If the pipe were to be upsized to a 72" RCP, the 100-year water surface elevation would be slightly lowered; however no dwellings would be removed from the 100-year flood plain. This is due to the fact that the existing elevation of Rainbow Drive at the culvert is considerably lower than either Carol or Lorainne; and therefore, overtopping of the road occurs earlier in the storm event. Once the road is overtopped the elevation of the flood increases much slower since the conveyance over the road is much greater than through the culverts.
