- Interview Summary
- Building Analysis
- Historical Data Analysis
- Facility Assessment

Town of Carrboro Facilities Assessment

STRUCTURAL FACILITITIES CONDITION ASSESSMENT

TOWN OF CARRBORO FACILITY CONDITION ASSESSMENT REPORT CARRBORO, NC

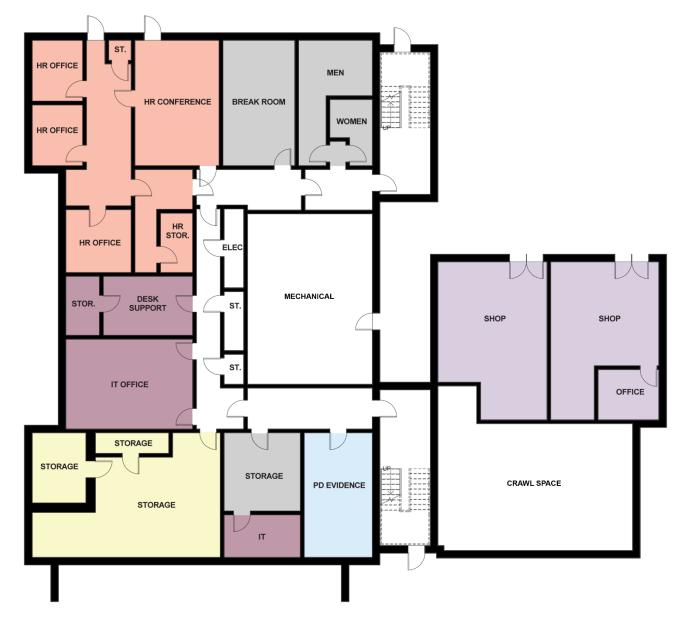
Town Hall Basement Floor Plan

- 6 departments totaling 4,751 NSF
- GSF of floor = 6,892 (69% program space)
- At grade exit from Human Resources
- Mechanical and electrical rooms
- Public Works, Recreation & Parks, and Police spaces

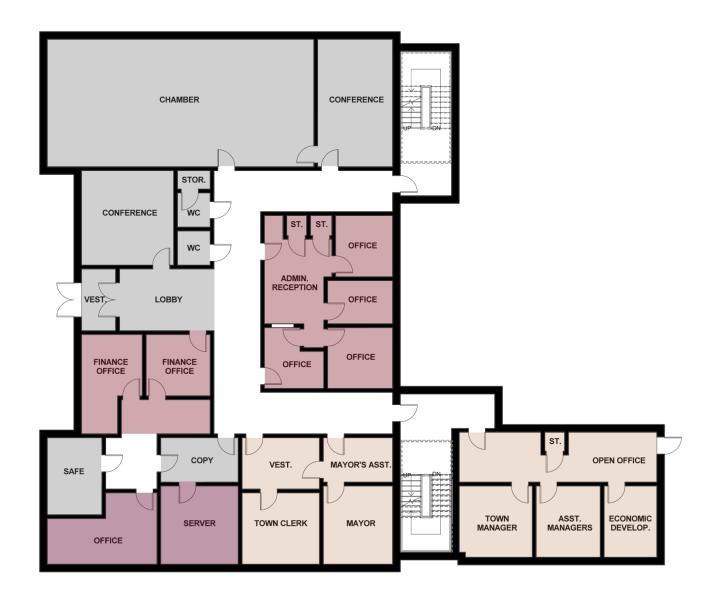
Town Hall First Floor Plan

- 4 departments totaling 5,054 NSF
- GSF of floor = 6,218 (81% program space)
- Main entrance to facility
- Board room and executive conference
- Public counter staffed by Finance
- Server room and safe

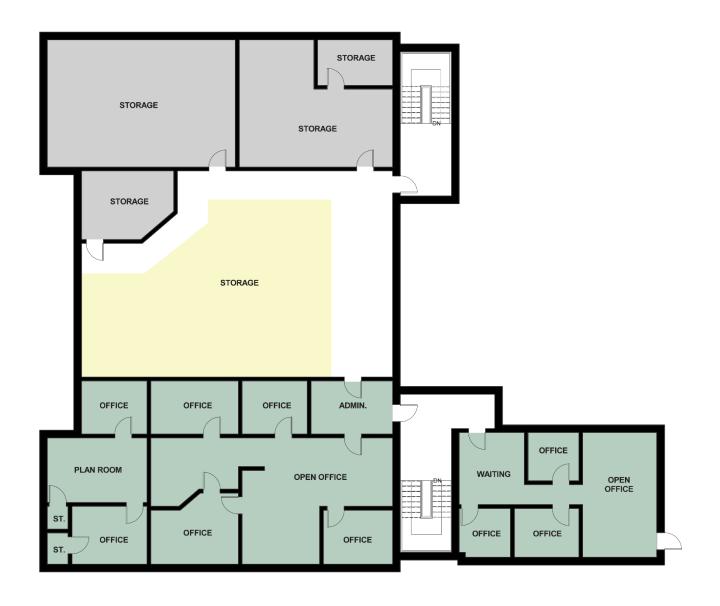
Town Hall Second Floor Plan

- 3 departments totaling 5,342 NSF
- GSF of floor = 6,218 (86% program space)
- Mostly attic space with R&P athletic storage
- Planning department
- Shared Town Hall storage

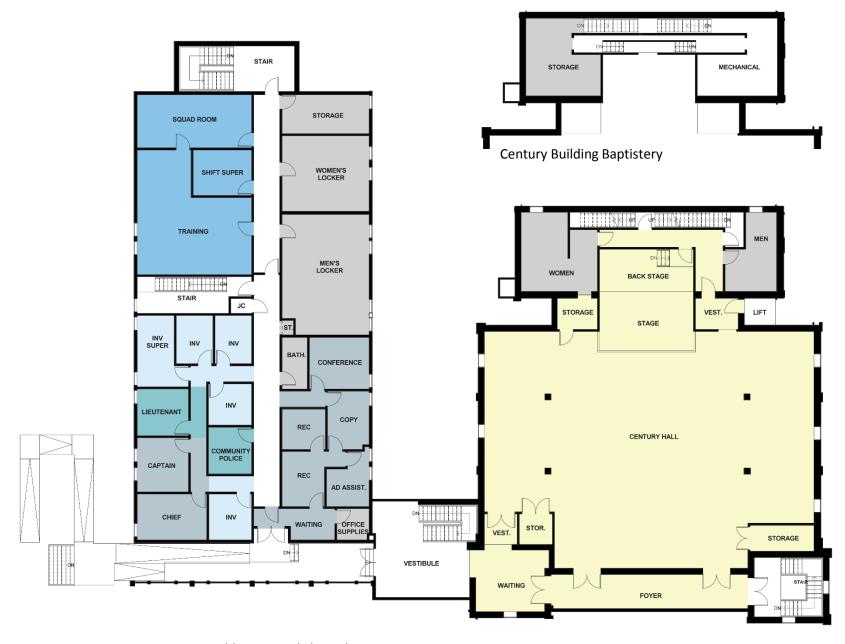
Century Building Second Floor Plan

- 7 departments totaling 9,496 NSF
- GSF of floor = 11,110 (85% program space)
- ADA entrance from corner plaza
- Common vestibule

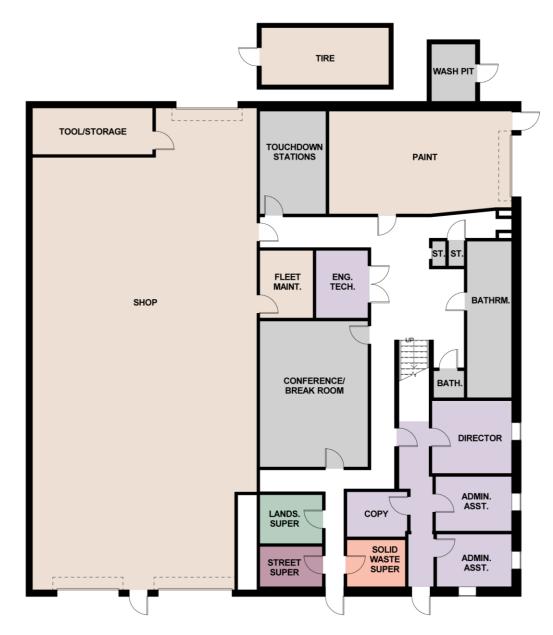
Public Works First Floor Plan – Interior

- 6 departments totaling 5,342 NSF
- GSF of floor = 6,264 (85% program space)
- Metal building
- Tight spaces

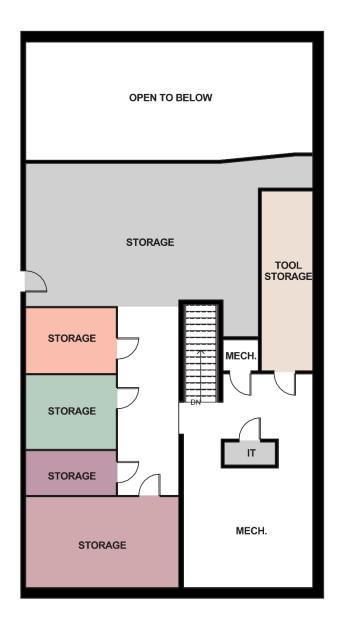
Public Works Attic Plan

- 10 departments totaling 1,533 NSF
- GSF of floor = 2,365 (65% program space)
- Unconditioned except for IT closet
- Headroom clearance issues
- Single means of egress

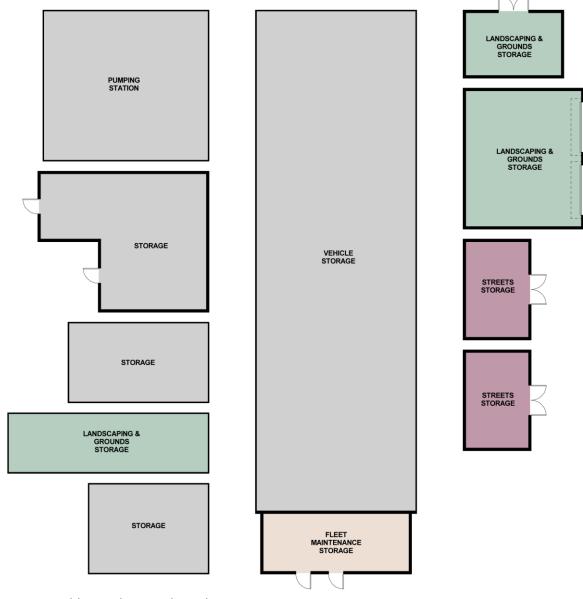
Public Works First Floor Plan - Exterior

- 6 departments totaling 8,200 NSF
- GSF of floor = 7,940 (100% program space)
- Outdoor covered storage
- Unconditioned space in service yard

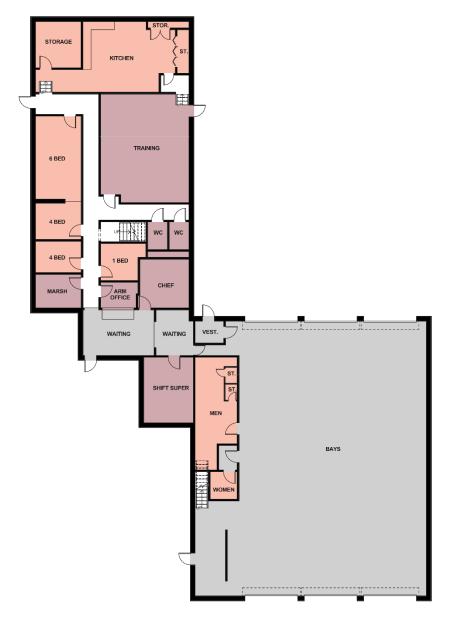
Fire Station 1 First Floor Plan

- 3 departments totaling 6,766 NSF
- GSF of floor = 7,424 (91% Program Space)
- Fire administration
- Training room
- Sleeping quarters
- Apparatus bays

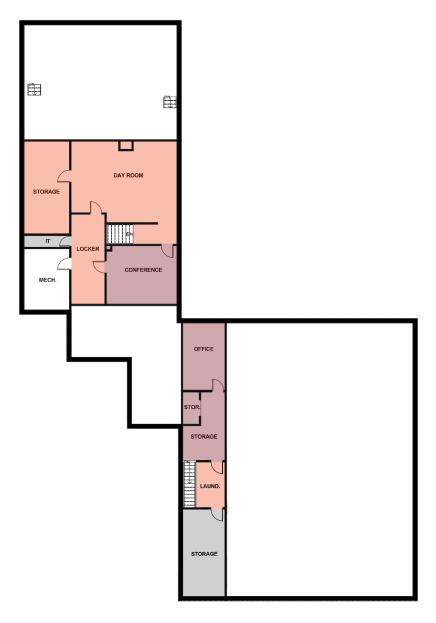
Fire Station 1 Second Floor Plan

- 10 departments totaling 2,060 NSF
- GSF of floor = 2,286 (90% Program Space)
- Day room and storage
- Conference room

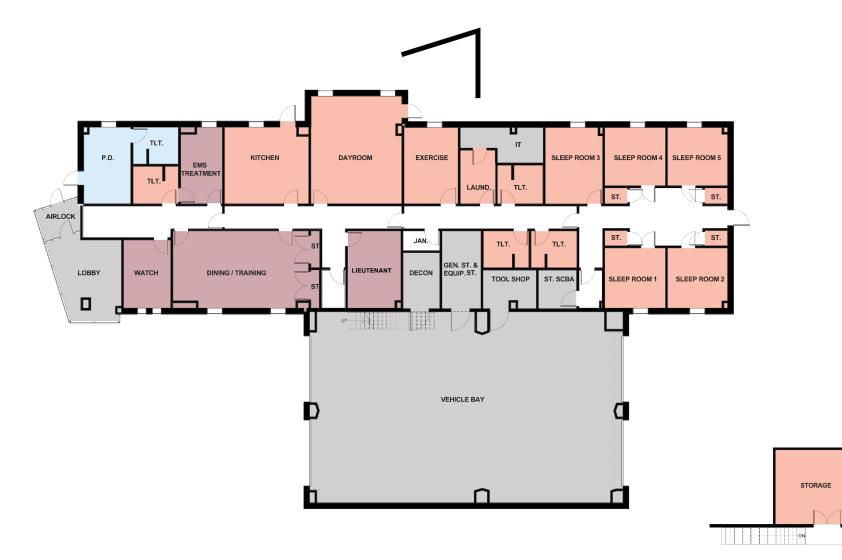
Fire Station 2 First Floor Plan Fire Station 2 Mezzanine Plan

- 4 departments totaling 7,008 NSF
- GSF of floor = 8,550 (85% program space)
- Newest facility
- Training room
- Police substation
