# **PRELIMINARY ENGINEERING REPORT**

## **Morningside Drive – Bolin Forest Drive Hydrologic Report**

**THE TOWN OF CARRBORO  
CARRBORO, NORTH CAROLINA**

**May 16, 2016**

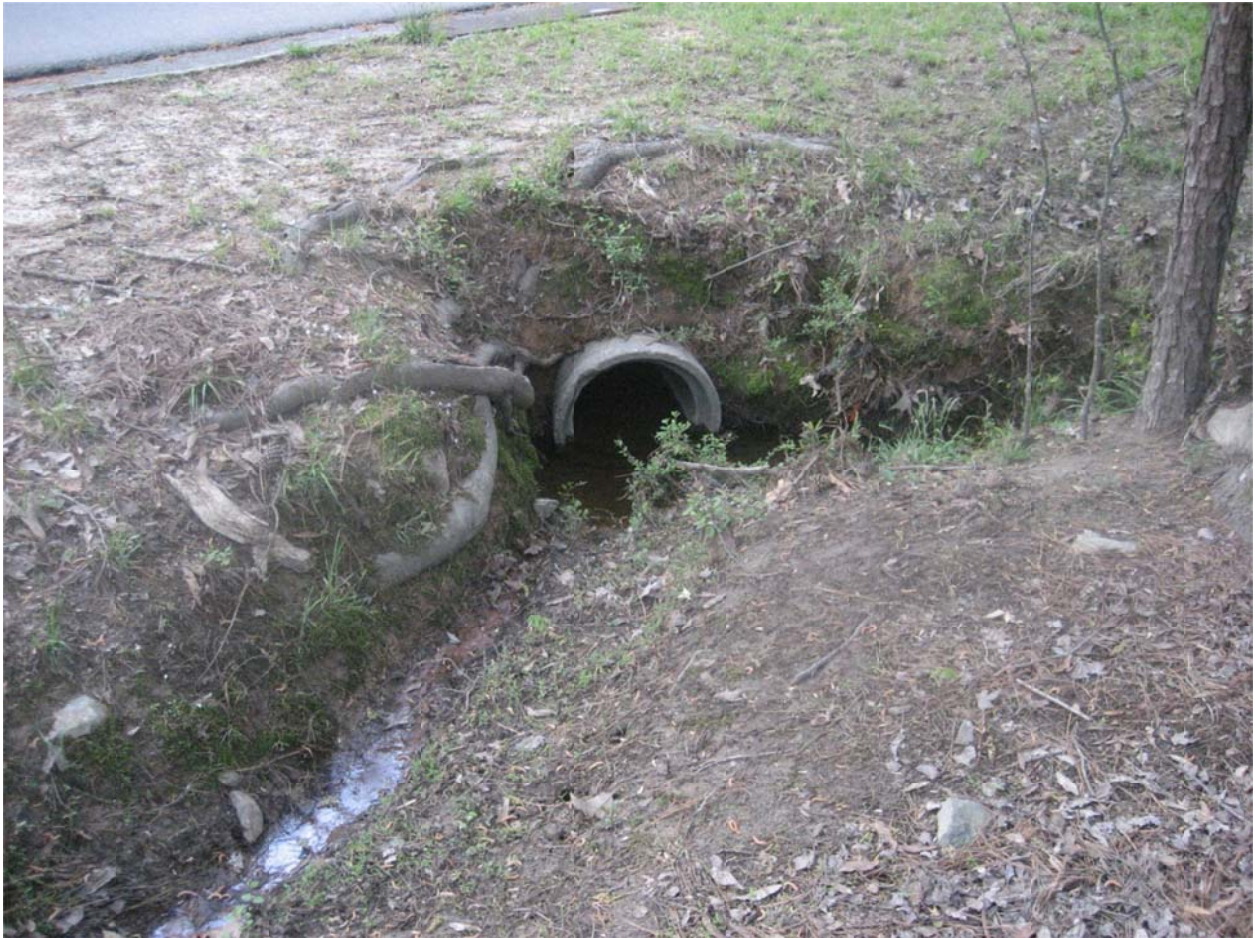
## Attachment 1

**18" RCP – Looking downstream toward Morningside Drive**

The existing crossing at Morningside drive consists of two separate 18" Reinforced Concrete Pipes (RCP) (**see Attachments 1 & 2**) that collect and merge into the 24" RCP crossing. The existing crossing at Robert Hunt drive consists of three 30" RCPs with Flared End Sections (FES) at the inlet and outlet of each pipe (**see Attachment 3**). The pipes are situated on a very sharp skew to the stream and roadway. The FESs at the inlet side have been modified by cutting away a portion of the structure that would otherwise be impeding flow due to the skew of the pipes to the stream. The existing crossing at Bolin Forest Drive is a 60"x44" Corrugated Metal Pipe Arch (CMPA) that has been mitered to conform to the roadway fill at the inlet and outlet (**see Attachment 4**).

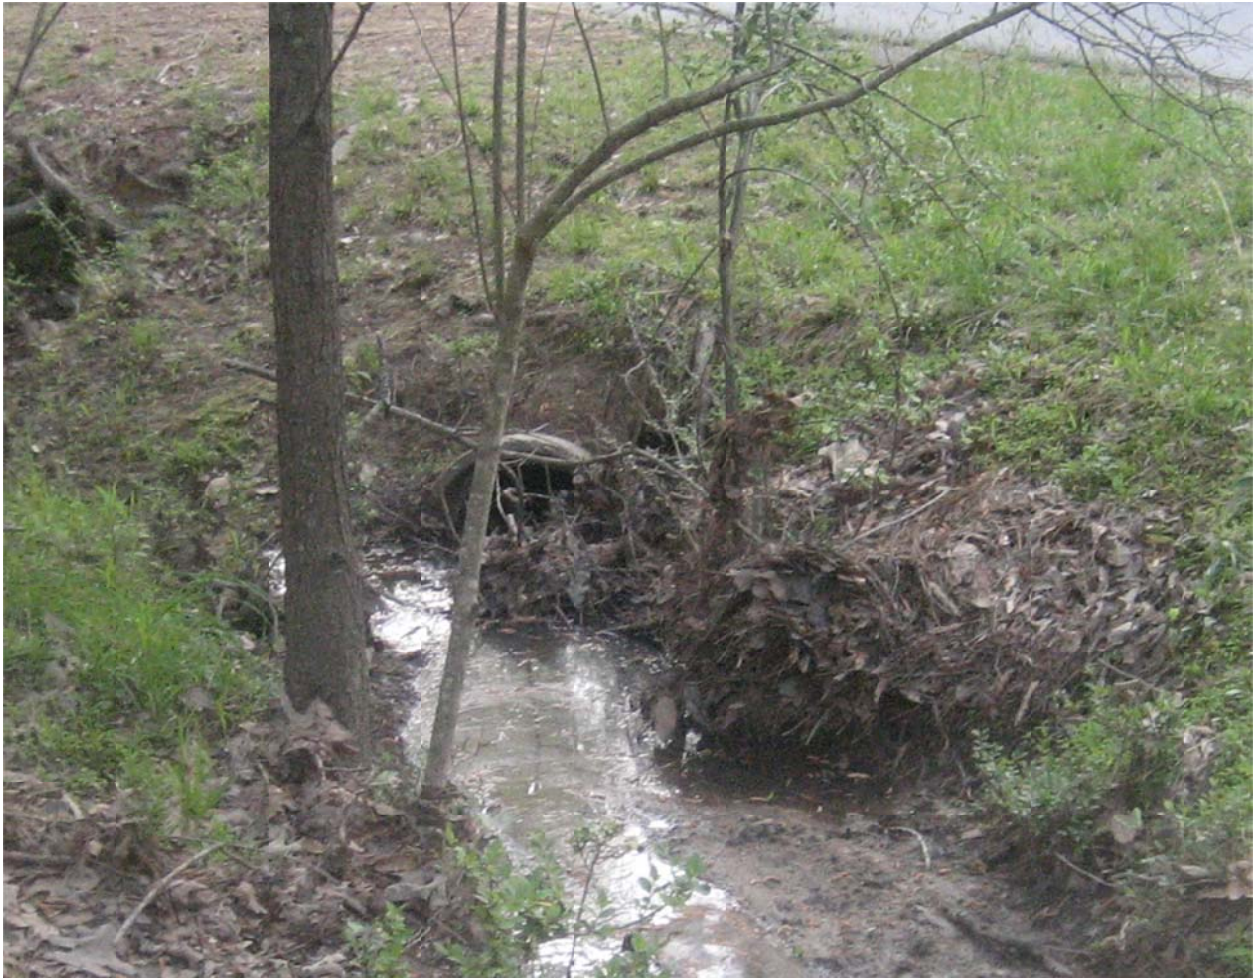
**Attachment 2**

**18" RCP – Looking downstream toward Morningside Drive**

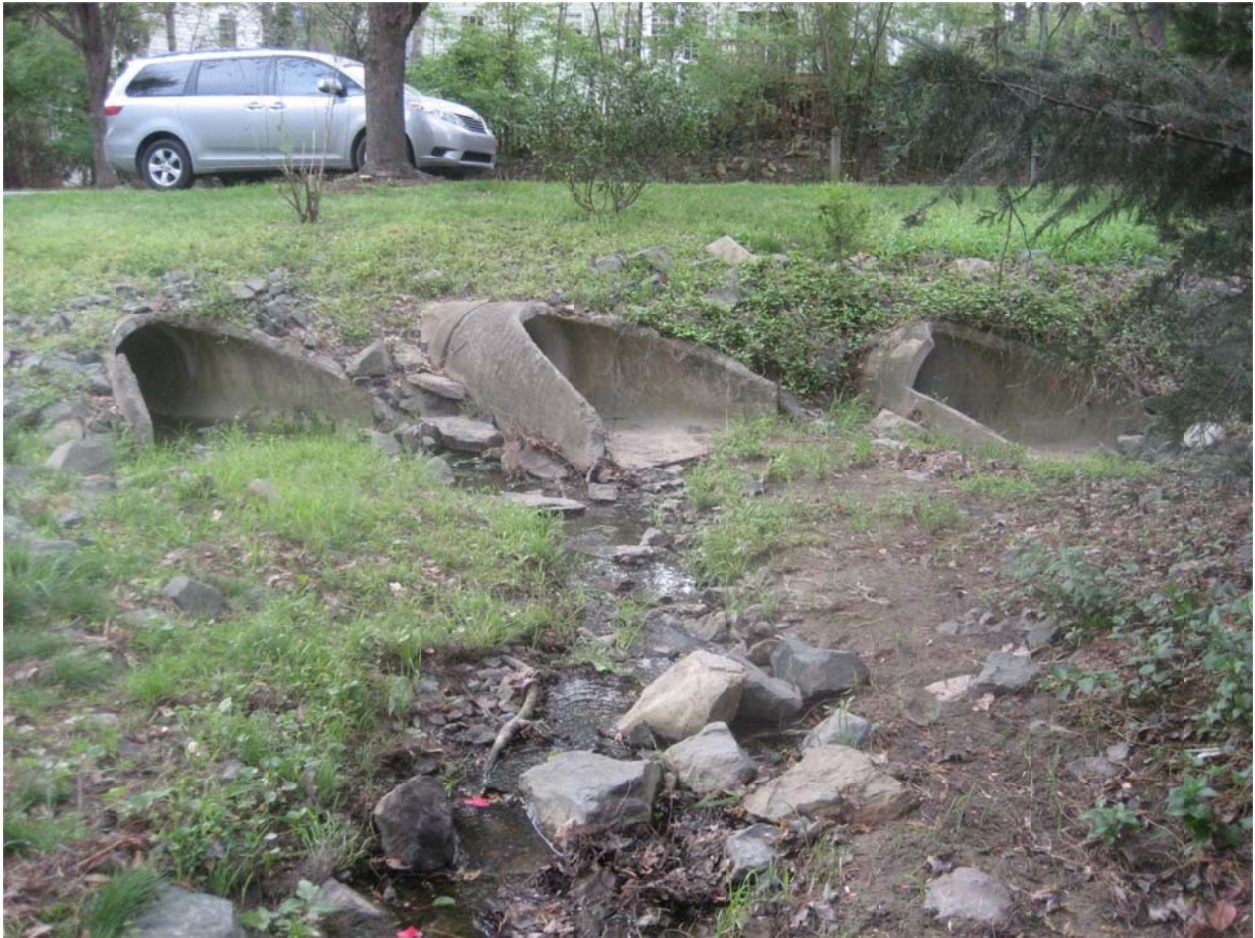
### Attachment 3

**3@30" RCP with Flared End Sections – Looking downstream toward Robert Hunt Drive**

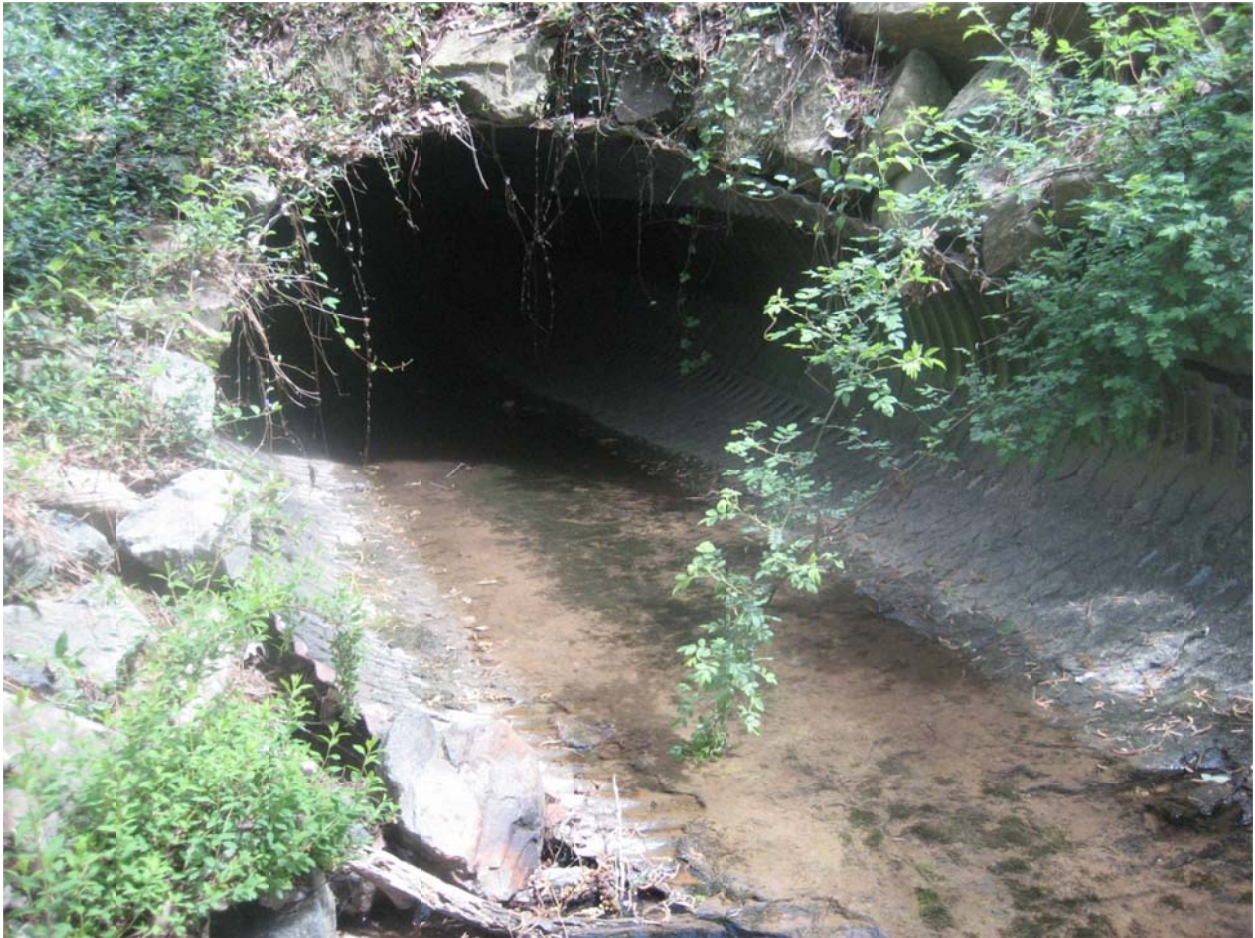
#### Attachment 4

**60"x44" CMPA - looking upstream toward Bolin Forest Drive**

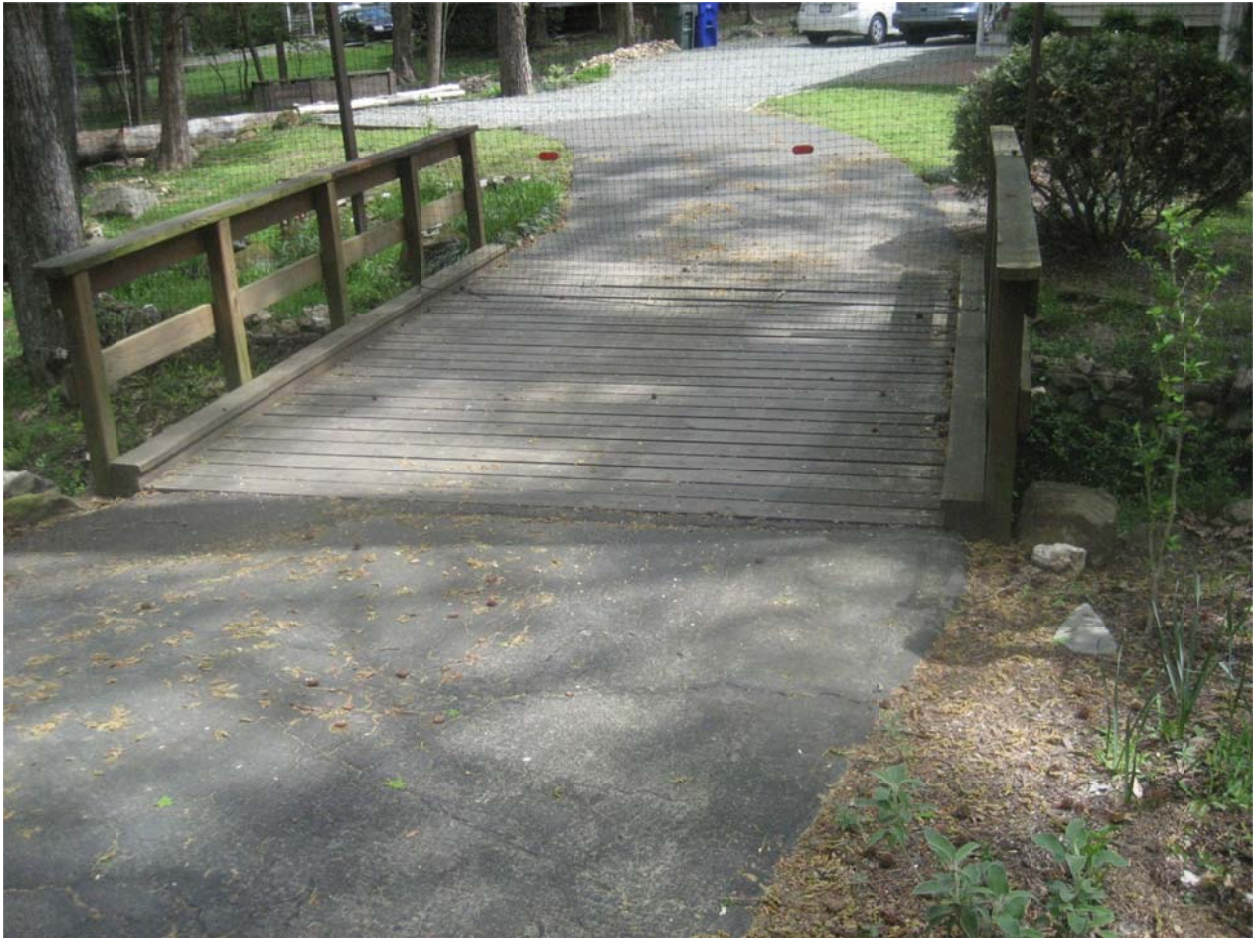
**Attachment 6**

**Driveway bridge at 310 Bolin Forest Drive**
