Town of Carrboro

Facilities Condition Assessment

October 2019

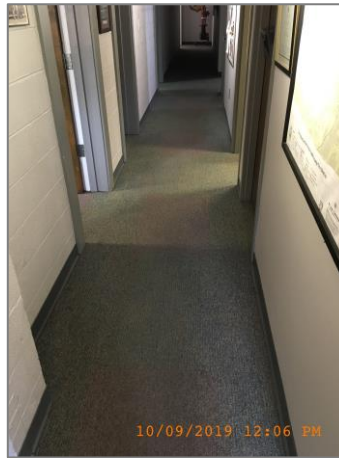
Carpeting in Hallway

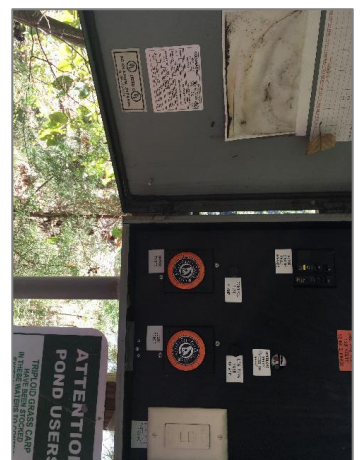
Electrical Panel (Near Pond)
