- Interview Summary
- Building Analysis
- Historical Data Analysis
- Facility Assessment

Town of Carrboro Facilities Assessment

STRUCTURAL FACILITITIES CONDITION ASSESSMENT

TOWN OF CARRBORO FACILITY CONDITION ASSESSMENT REPORT CARRBORO, NC

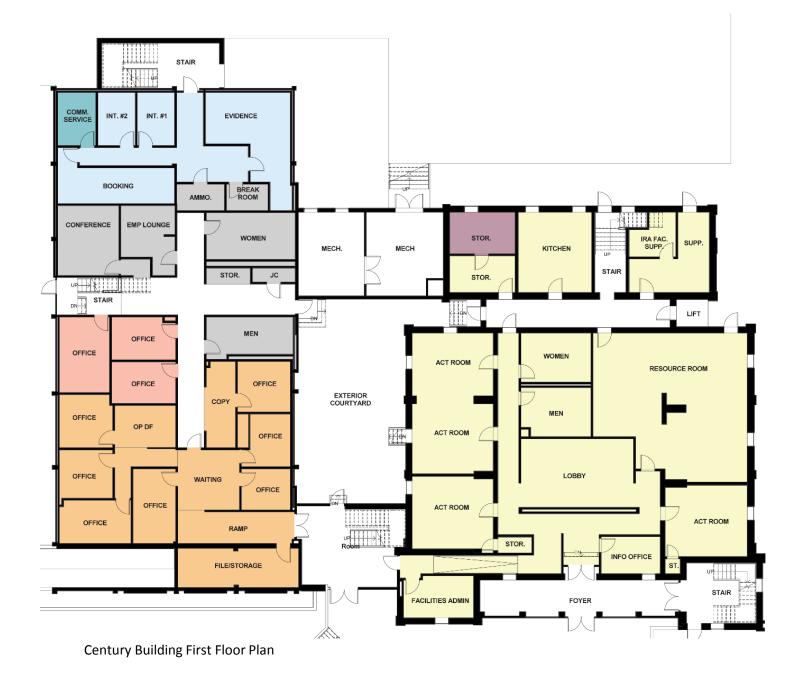
First Floor Plan

- Building has nice rental amenities including the Century Hall space
- Central downtown location
- Challenging relationship to street level requires multiple ramps and concealed entries
- Lack of identity for either police or recs and parks as a civic entity
- Several office spaces interior to the building with no access to daylight
- Lack of secure area for police detainee transfer in rear parking lot

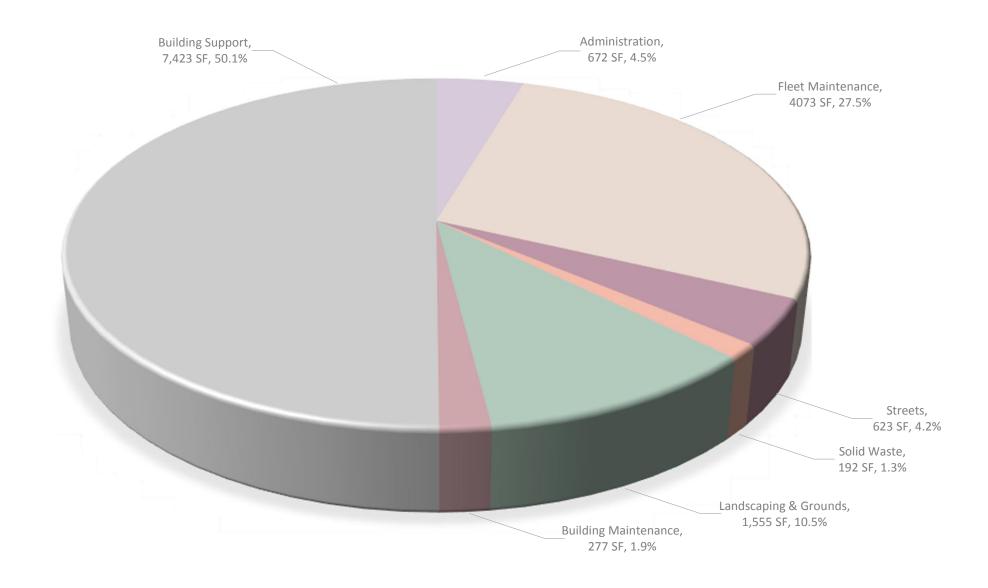
- Site is centrally located near downtown and most town facilities
- Most office deficient in space and storage
- Conference/training/break room shared space has too many functions and limits access
- Shortage of female restrooms
- Property subject to flooding in proximity to fleet vehicle parking areas
- Vehicle bay too short for maintenance on some fleet vehicles
- Police conversions and vehicle evidence processing occupies valuable bay space
- Public access to the site for mulch program

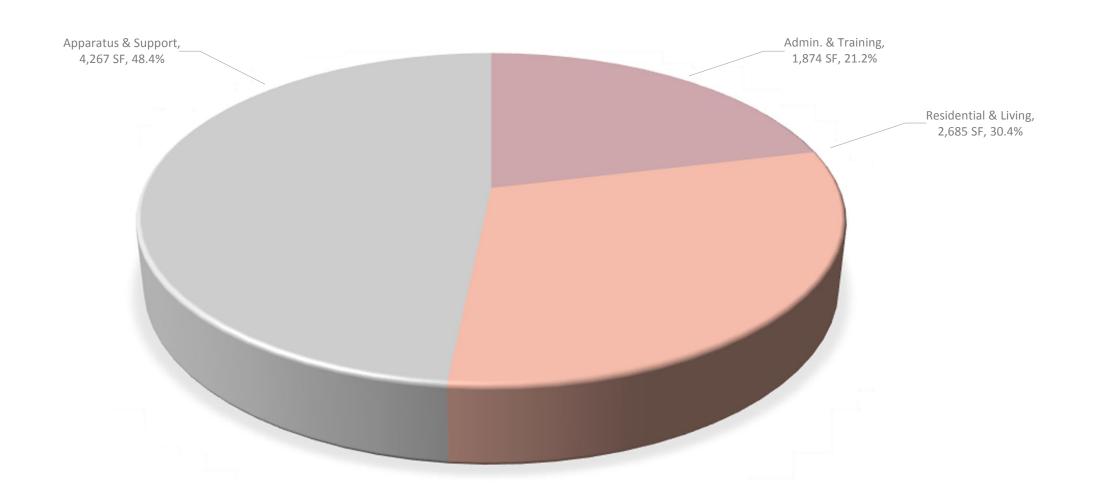
- Site is centrally located near downtown
- Shortage of parking spaces
- Apparatus bays are lacking in space and height – some vehicles being parked outside
- Lack of separation between administration and station functions
- Conference room under utilized due to lack of AV
- Sleeping quarters very cramped
- No secure public lobby
- Training room shared with other departments

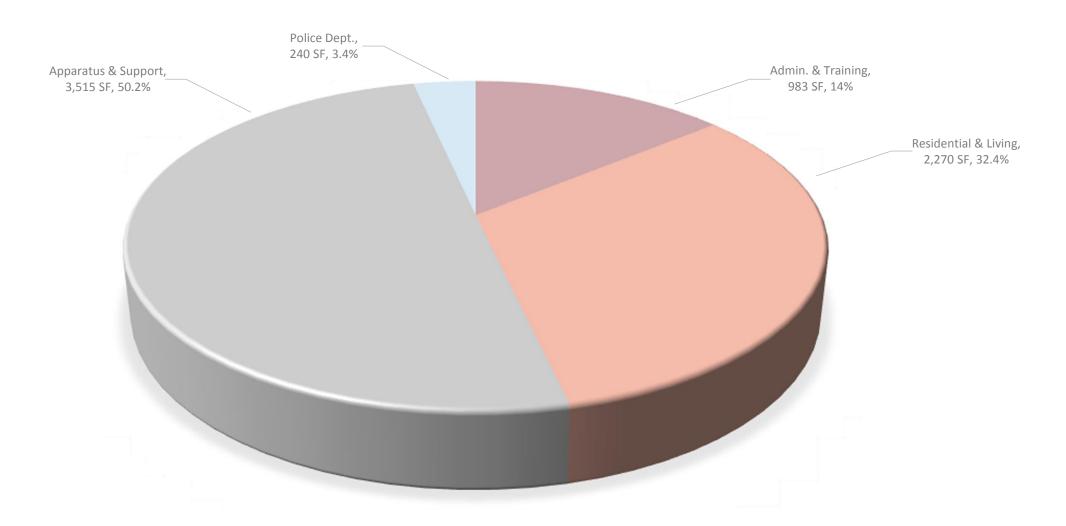
- Newest facility owned by the Town and in great condition
- Sited for potential expansion of apparatus bays
- Shared sleeping rooms
- Nice kitchen
- Height of apparatus bays adequate but the length for double stacking is lacking
- Police substation
- Nice outdoor patio space
- Adequate staff parking
