PAVEMENT CONDITION SURVEY

Town of Carrboro

April 2019

**LaBella Associates, P.C.
400 S. Tryon Street, Suite 1300
Charlotte, NC 28285**

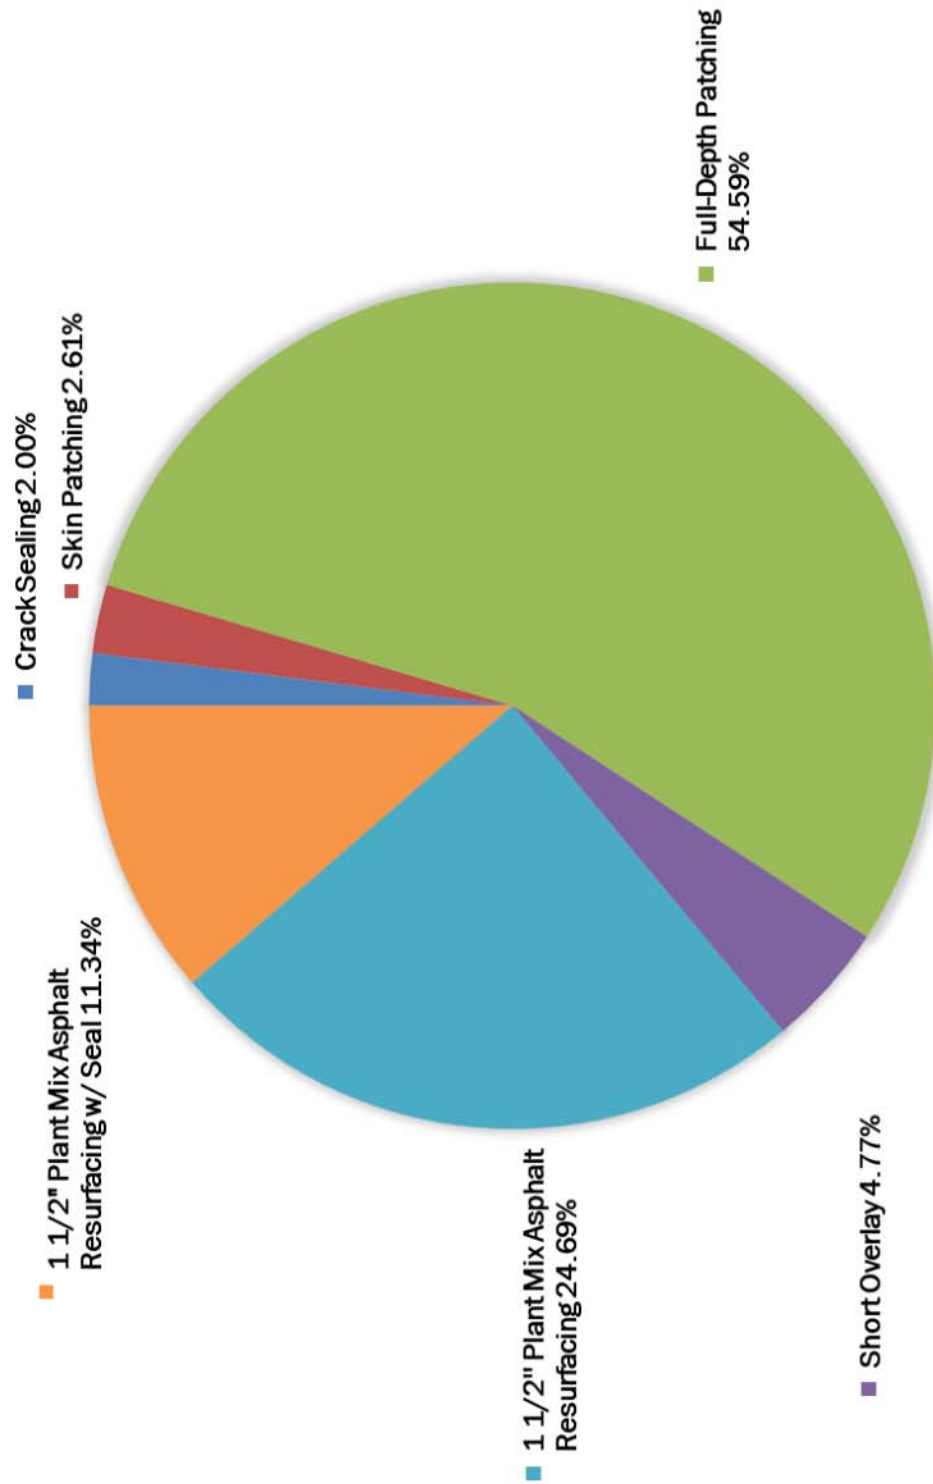
Figure 4 - Distribution of Maintenance Costs by Primary Type
Percentage of Total Cost
Total Cost: \$657,292

Figure 4, on page 18, illustrates how the total cost is distributed among the various recommended maintenance activities. Approximately 36.03% of the system's cost is for maintenance in the form of resurfacing, as a primary maintenance activity that includes all necessary patching.
