Town of Carrboro

Facilities Condition Assessment

October 2019

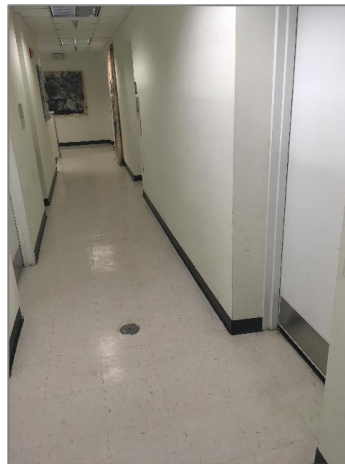
Laminate Flooring

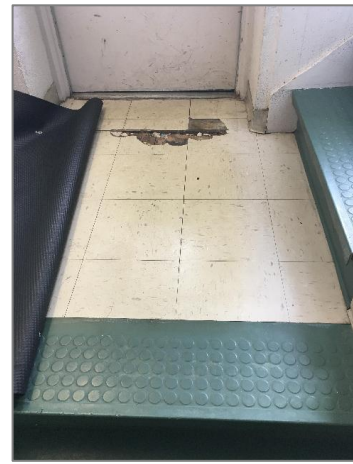
Laminate Flooring

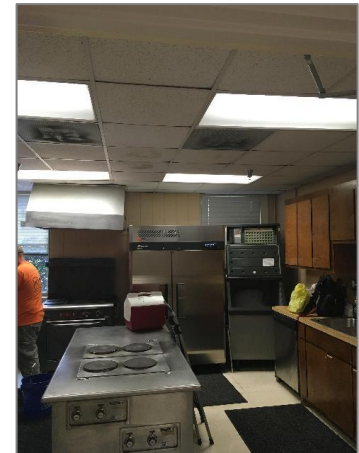
Kitchen

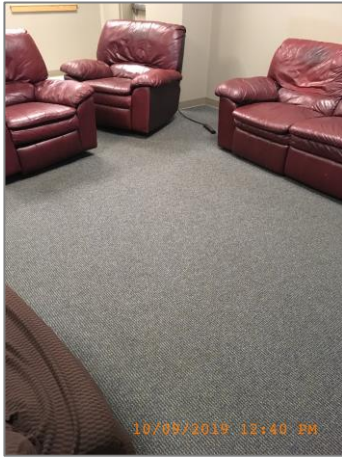
Day Room Carpet

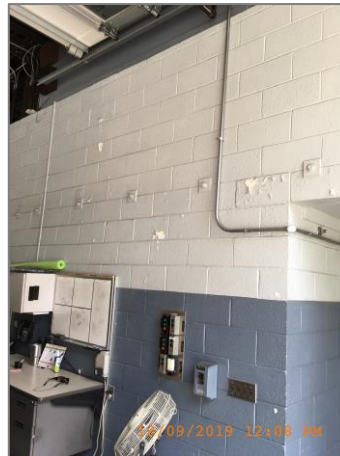
Interior Bay Wall

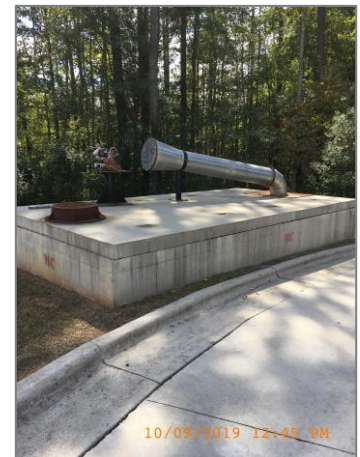
Fire Station 2 is in good overall condition. It is recommended that building components be monitored so that degradation does not occur. Currently, the water reclamation system is down for maintenance and needs to be repaired and reconnected. The concrete test pit is leaking and needs to be repaired or replaced.

Test Pit

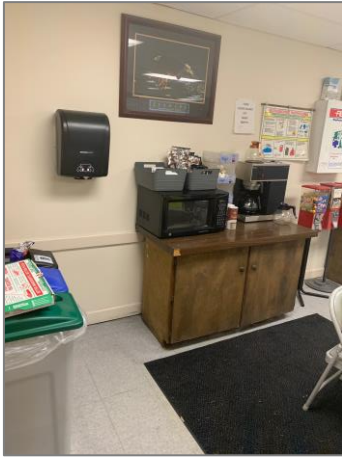
The Public Works facility should be reevaluated so as to use the limited space more effectively. The asphalt parking lot is in poor condition and resurfacing is recommended in the near future. The restrooms and breakroom should be remodeled to meet current standards and accommodate the needs of the department. Currently the mechanics perform a lot of work in front of the Fleet Maintenance Bay, open to the elements, it is recommended that an open air awning or port be installed in front of the bay to provide a better working environment for the mechanics. The vehicle wash station does not currently comply with OWASA standards and needs to be modified. Various modifications to structures and storage should be considered due to the history of flooding.

Break Room

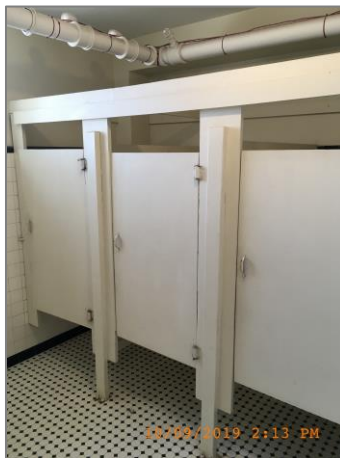
Water Closet

The plumbing is in poor condition and the number of bathrooms is inadequate for the building. Piping for the plumbing system is of varied material and corrosion is evident throughout the building.

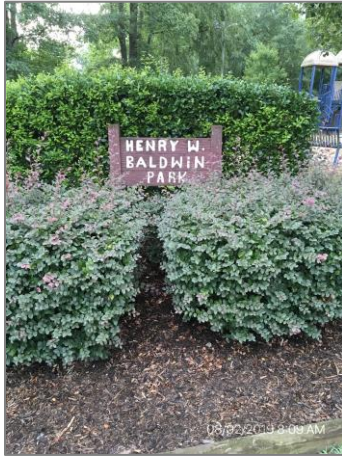
Sign

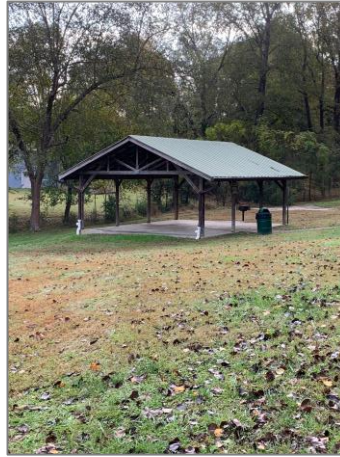
Pavilion

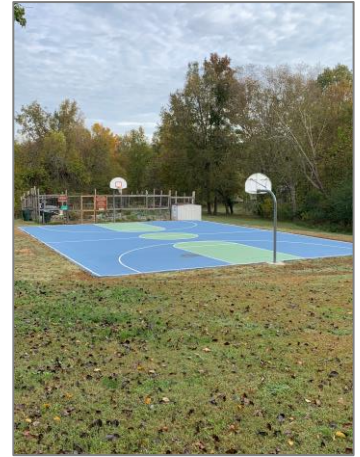
Basketball Court

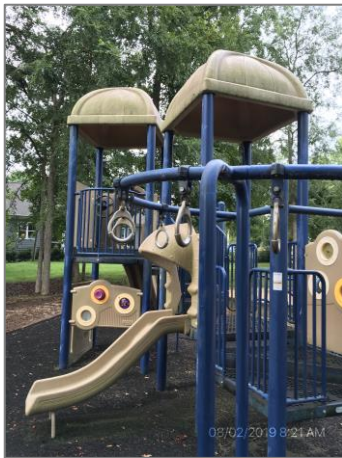
Play Equipment

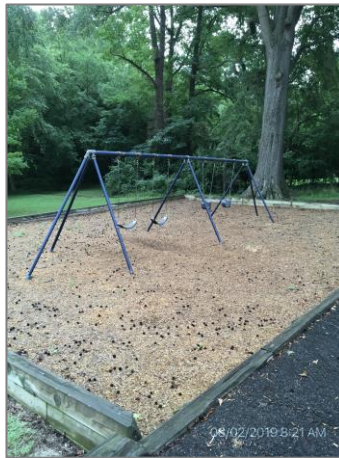
Play Equipment

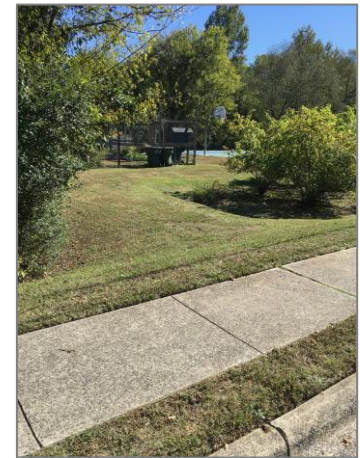
There is currently no sidewalk to the community garden. It is recommended that an ADA compliant sidewalk be installed at this location.

Sidewalk & Raingarden

Location	Asset System	Asset Type	Description/Recommendation	Quantity	Opinion of Cost
Site	Accessibility	Sidewalk	No access to community garden that meets ADA guidelines. Recommend installing new sidewalk.	1	\$15,000
Total Opinion of Cost					\$15,000

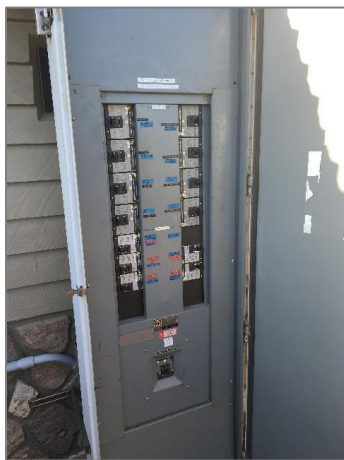
Electrical Panel

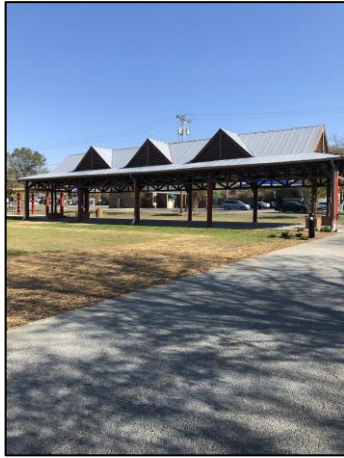
Pavilion

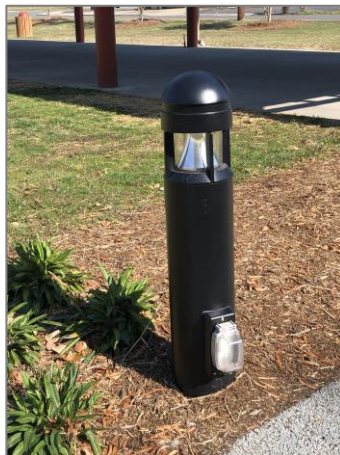
Location	Asset System	Asset Type	Description/ Recommendation	Quantity	Opinion of Cost
Site	Electrical	Exterior Lighting	Bollard light fixtures are always on. In order to make the outlets work with the lights turned off, additional wires would need to be pulled through the conduit to the bollards.	12	\$5,000
Site	Electrical	EV Charge Station	One of the automatic cable retractors is broken, this leads to cable laying on the ground where it is more likely to be driven over. Recommend repairing/replacing The cables are getting twisted and worn, these will need to be replaced eventually.	1	\$500
Site	Electrical	Electrical Panels	Panel LP200's labels are missing or unreadable. Recommend mapping and relabeling branch circuits.	1	\$250
Site	Electrical	Electrical Panels	The equipment grounding conductors at panel LP100 are exposed to physical damage. Recommend rerouting and possibly sleeving the grounding wires to protect them from damage.	1	\$100

Bollard

The bollards providing area lighting stay on 24/7, it is recommended that these be modified so the light turns off during the day. The permeable pavement parking lot needs routine maintenance in order for the surface to maintain its permeable trait. Regular vacuuming of the surface is recommended. The pavilion structures will need to be stained and possibly repaired in the next four years. The pavilion roofs should be inspected periodically for leaks and repaired as necessary. The green space gets heavy use by the farmers market; therefore, erosion and irrigation should be closely monitored.

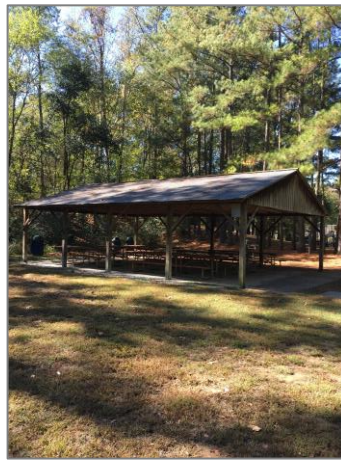
Picnic Shelter

Location	Asset System	Asset Type	Description/ Recommendation	Quantity	Opinion of Cost
Site	Architectural	Roof - Picnic Shelter	Roof leaks and needs to be replaced.	1	\$7,500
Site	Architectural	Amenity - Picnic Tables	Tables and benches need to be painted.	4	\$1,000
Site	Electrical	Support Structure	There is a lot of rust damage on the Unistrut supports for the main service gear. Recommend cleaning and painting Unistrut.	1	\$250
Site	Electrical	J-box	The pull box beside the main panel is missing a KO seal. Recommend installing a KO seal	1	\$100
Total Opinion of Cost					\$8,850
